Property Location: 203 West Main Street, Morrison, IL 61270

INSPECTION REPORT

Prepared For: Gold Standard Ventures

Date of Inspection: 6/2/2025

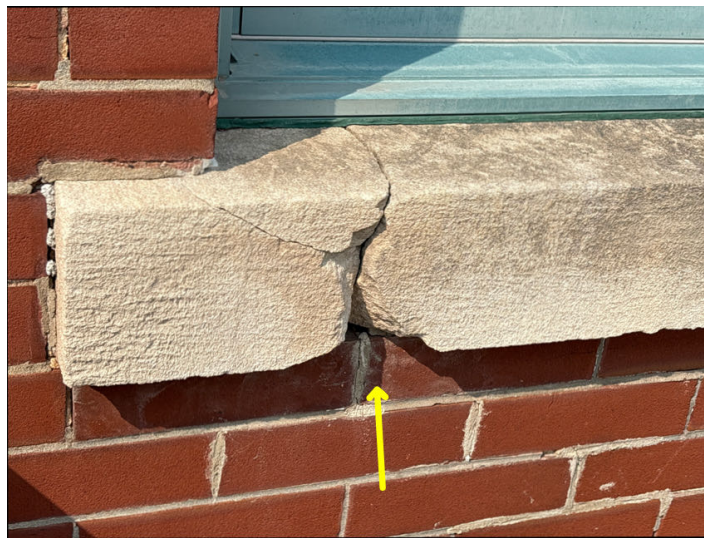
Damage to one stone window ledge was observed. This may allow water to penetrate behind the brick as well as water to enter the building. Water may cause damage to structural components, interior finishes, and may encourage mold growth. All damage should be repaired before additional damage occurs. Recommend contacting an appropriate reputable contractor to assess and repair as needed.

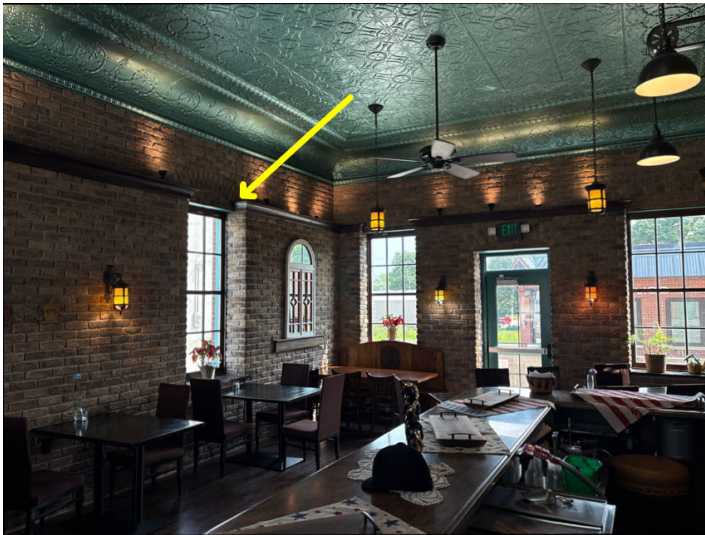
Per the bakery Café owner Shelly, two windows leak water when certain rain conditions are met. One window is in the east dining room south east corner east wall.

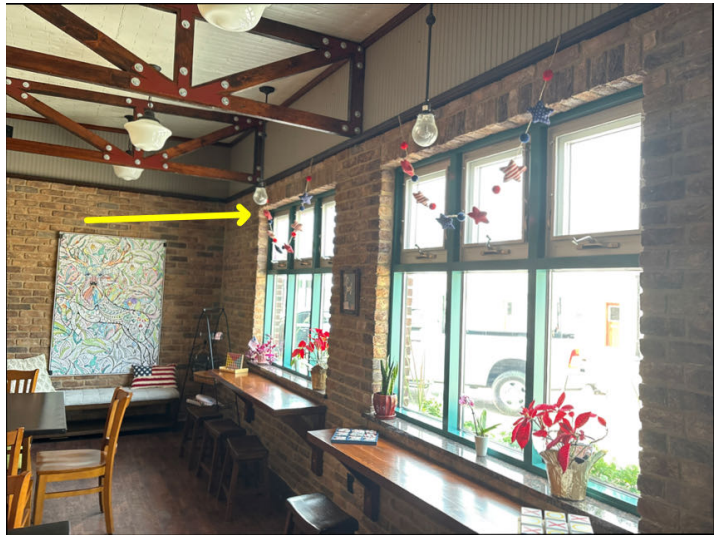
Per the bakery Café owner Shelly, two windows leak water when certain rain conditions are met. One is in the west dining room north wall.

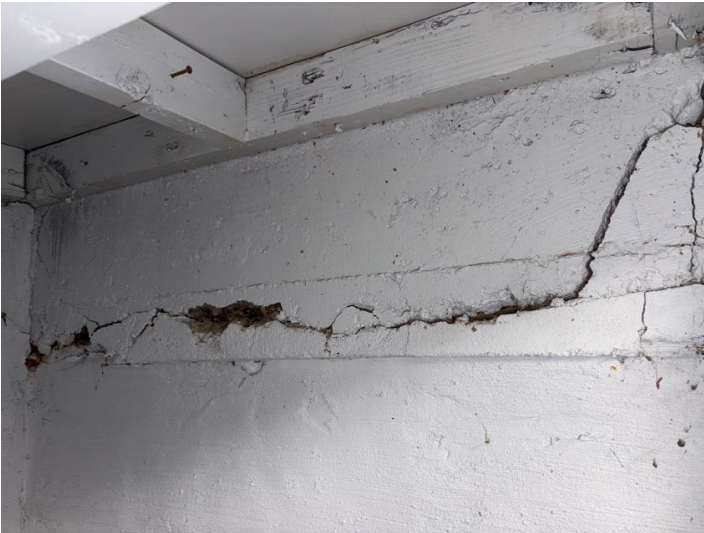
Damage/crack observed. This may affect the structural integrity of the foundation. All damage should be repaired before additional damage occurs. Recommend contacting an appropriate reputable contractor to assess and repair as needed.

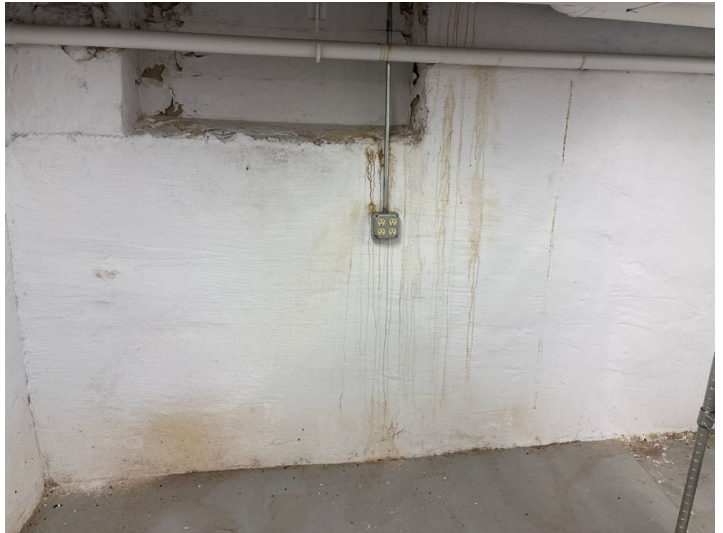
Damage/crack observed. This may affect the structural integrity of the foundation. All damage should be repaired before additional damage occurs. Recommend contacting an appropriate reputable contractor to assess and repair as needed.

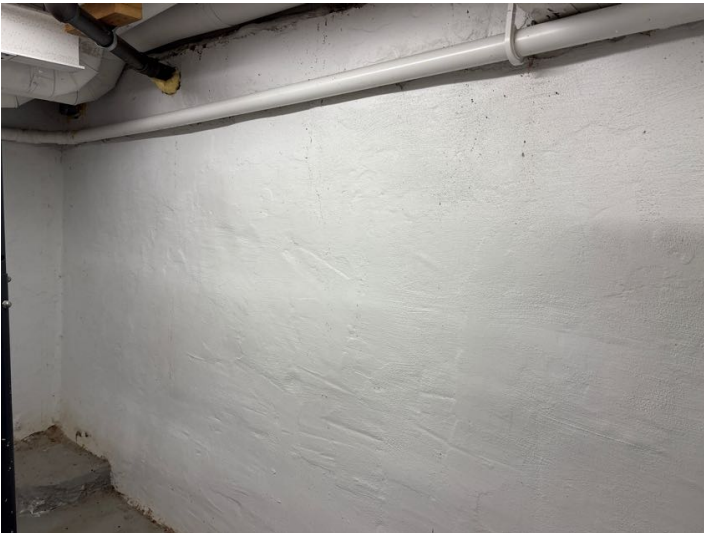
Evidence of moisture intrusion observed. Moisture can damage building finishes and structural components as well as contribute to the development of mold. Recommend contacting an appropriate reputable contractor to assess and repair as needed.

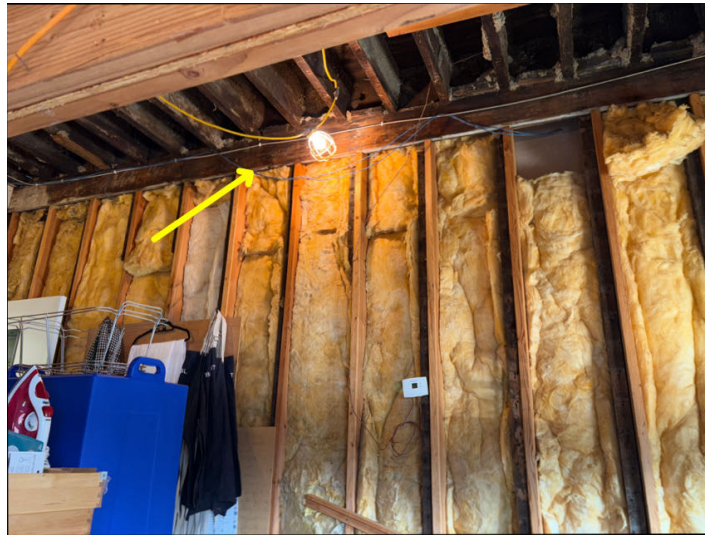
Per the bakery Café owner Shellie the east wall of the garage, leaks water when certain rain conditions are met

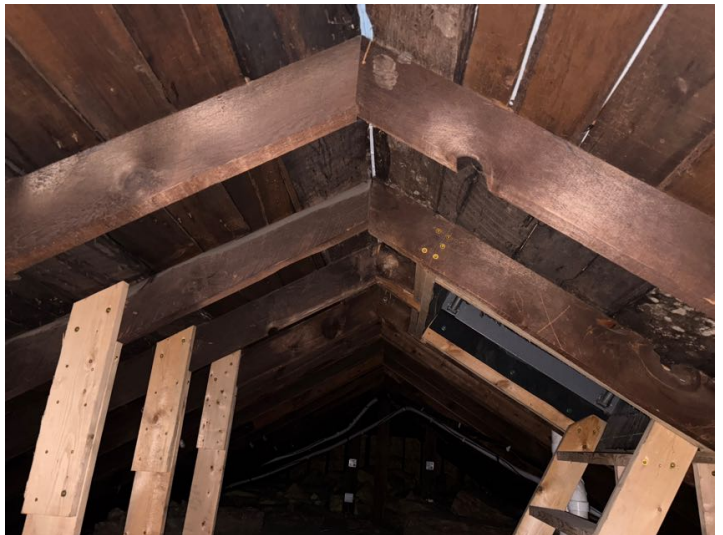
The corporate rental unit attic space/roof structure scuttle access was obstructed by the television and not accessible. Attic space, roof structure, and components were not inspected. Condition is unknown.

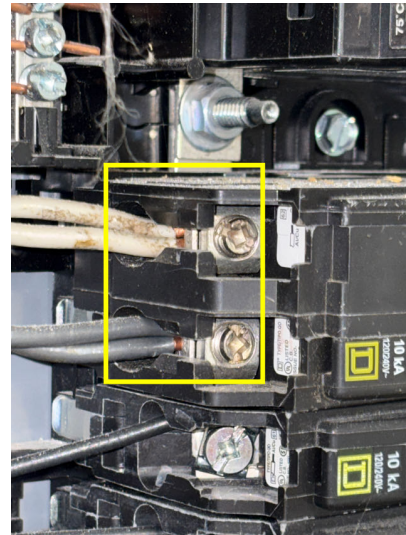
The Airbnb electrical panel was located in the bathroom. This creates a potential hazard and is considered less safe. Recommend contacting a certified electrical contractor to properly relocate the panel.

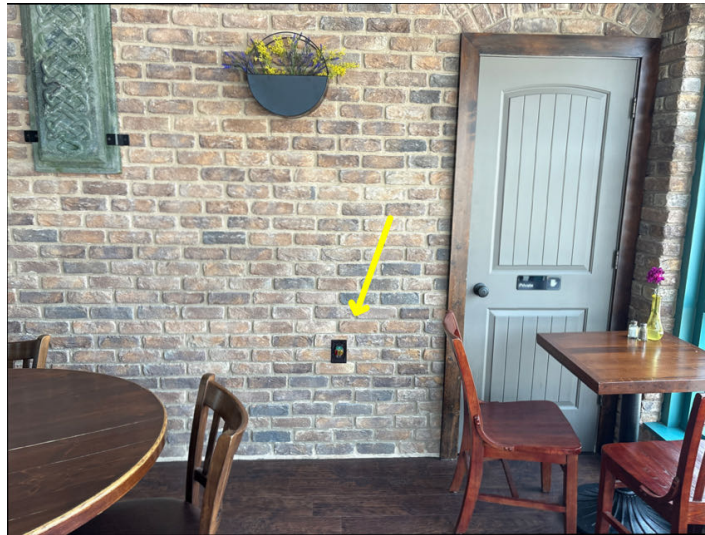
The bakery cafe east dining room receptacle left of the door to the corporate rental stairwell was inoperable. The receptacle may be ground fault protected, controlled by a switch, or a problem may exist with the receptacle and wiring may represent a potential hazard. Recommend contacting a certified electrical contractor to assess and repair as needed.

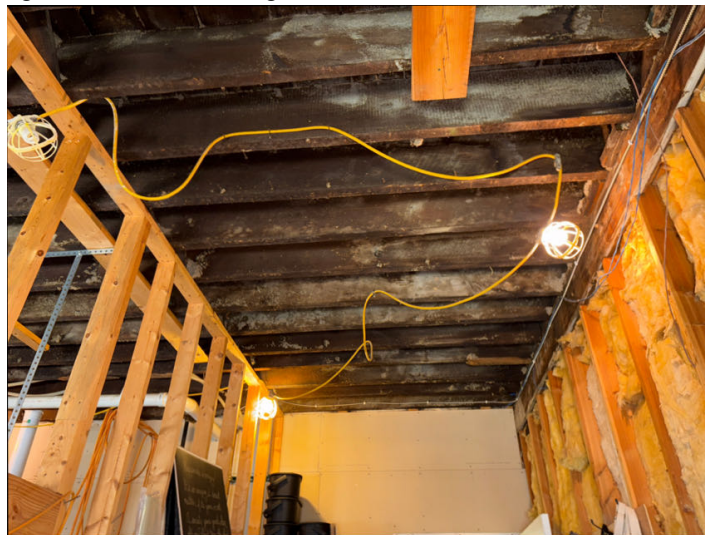
The basement west room and the garage were not equipped with light fixtures. Temporary work lights were hung and in use. Recommend permanent light fixtures and wiring be installed.

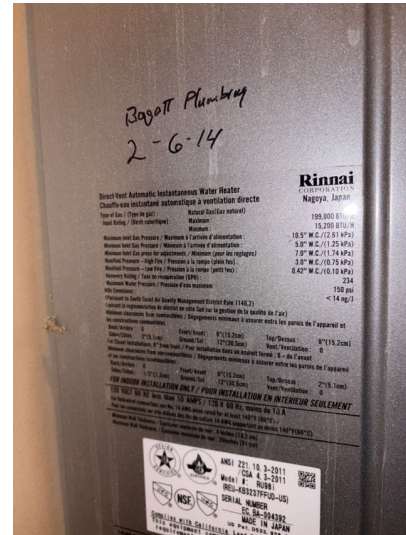
REPAIR - Water leak from the bakery cafe left unit observed. The bakery cafe owner stated the unit also shuts down and displays an error code on a regular basis. Recommend contacting a reputable licensed plumbing contractor to assess and repair as needed.

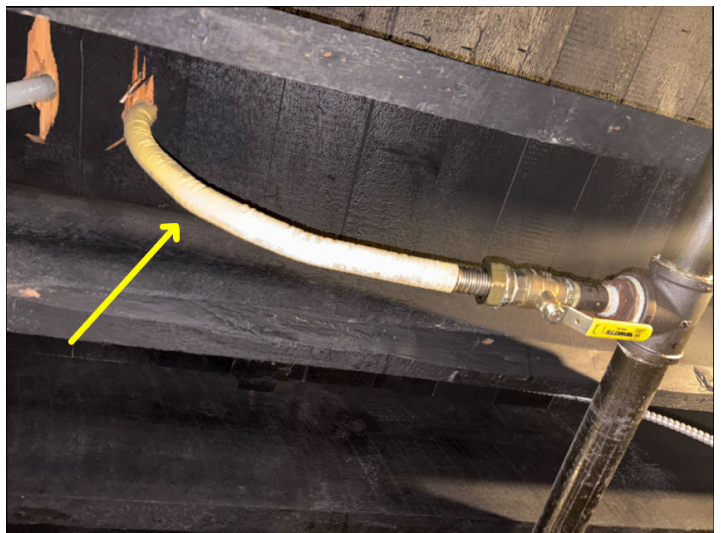
Corrugated Stainless Steel Tubing (CSST) was present with no visible electrical bond to the grounding electrode, electrical service equipment enclosure, or the grounded conductor at the electrical service. When no electrical bond is present this may lead to pin holes in the tubing, gas leaks and fire from lightning strikes directly to or near the home. Recommend contacting an appropriate reputable contractor to properly bond the CSST to the electrical grounding system. The CSST may also be replaced with another appropriate material by a licensed plumbing contractor.

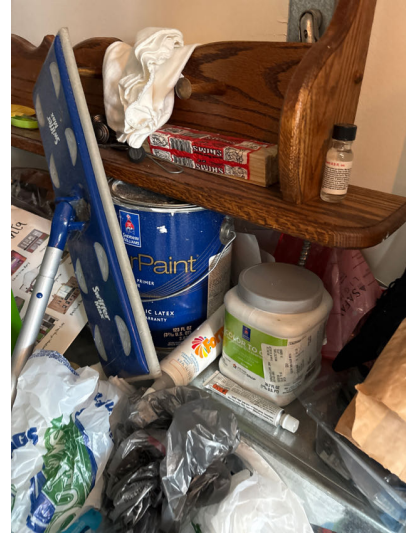
Storage, paints and wood stain were stored in the corporate rental unit furnace room. Recommend flammable items be removed.

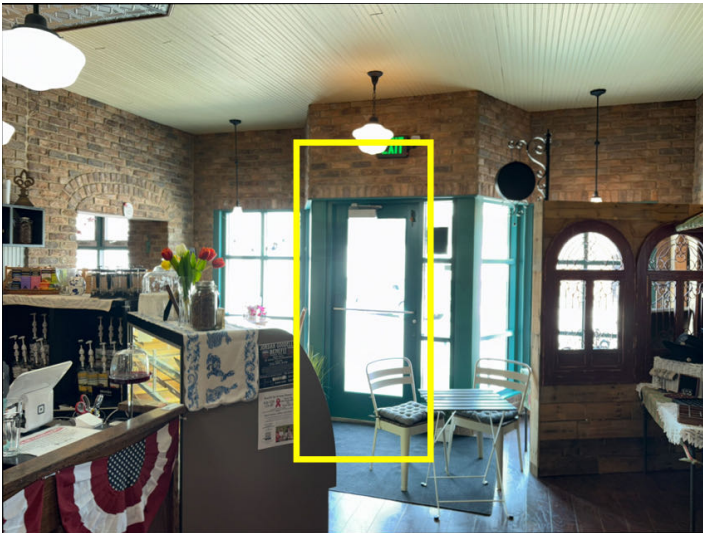
The bakery Café exit doors (deadbolt/no panic bar) were not labeled “doors must remain unlocked during business hours”. Recommend signage to be installed stating such.

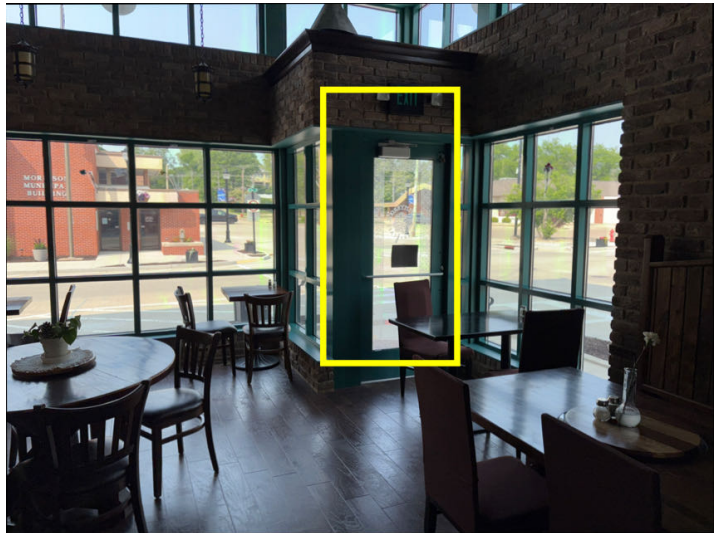
The bakery Café exit doors (deadbolt/no panic bar) were not labeled “doors must remain unlocked during business hours”. Recommend signage to be installed stating such.

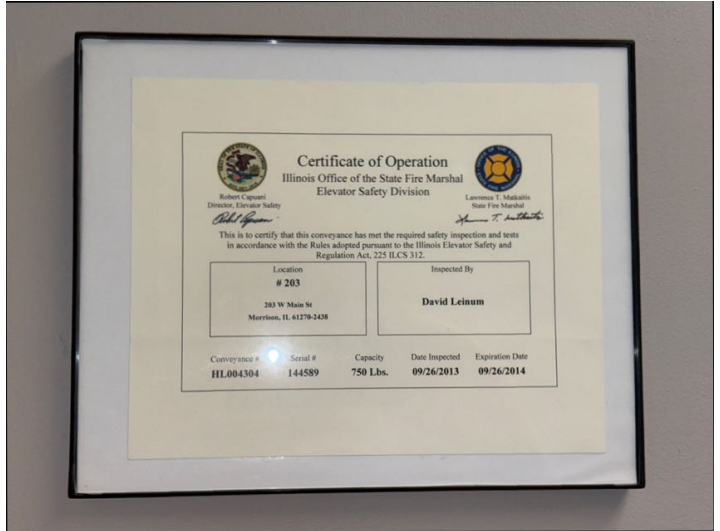
The certificate of operation expired September 26, 2014.
