Insight Home Inspections

Property Inspection Report

123 Sample Report Drive, Moline, IL 61265
Inspection prepared for: Sample Report
Date of Inspection: 1/1/2019 Time: 8am
Age of Home: Built in 1835 Size: 3322 Finished Square Feet

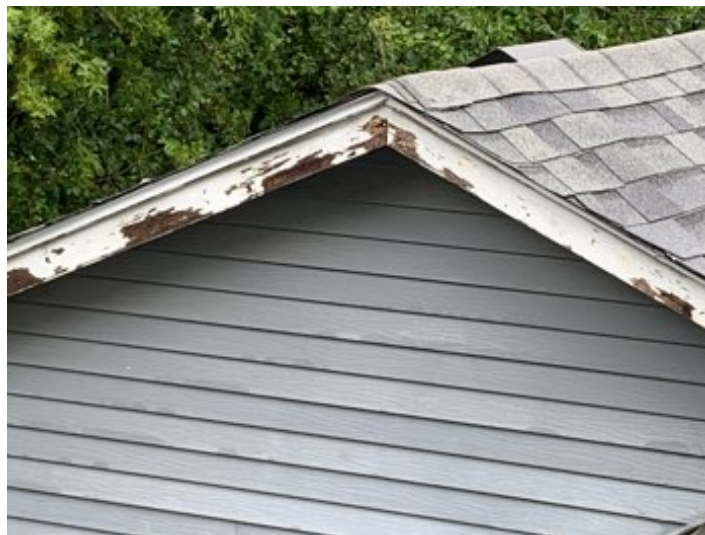
MAINTENANCE - Sections were in need of paint or stain. This is to protect the surface from the elements and reduce the chances for deterioration damage. Recommend painting/staining upon possession of the home.

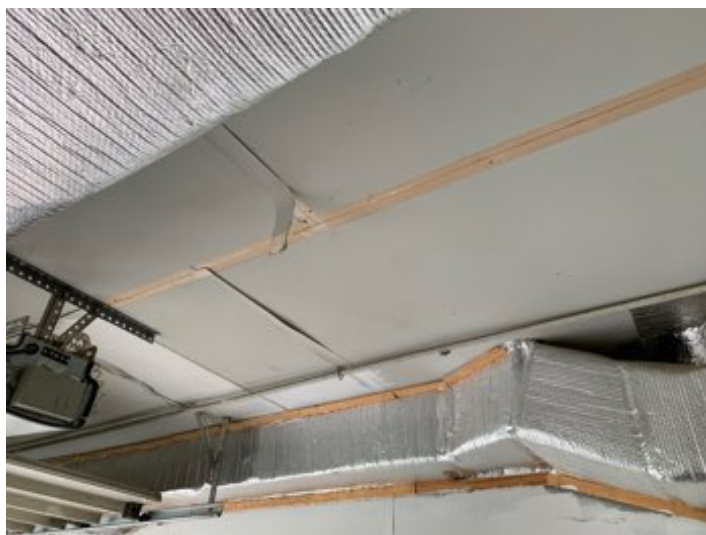
REPAIR - The fire separation from garage to living space has been compromised. All walls, ceilings and ductwork in the garage shared with the living space should be of a continuous fire resistant material. Large openings should be covered with an appropriate fire resistant material. Holes, seams, and gaps should be filled with a fire resistant material such as drywall compound, fire resistant sealant or putty. Recommend contacting an appropriate reputable contractor to assess and repair as needed.

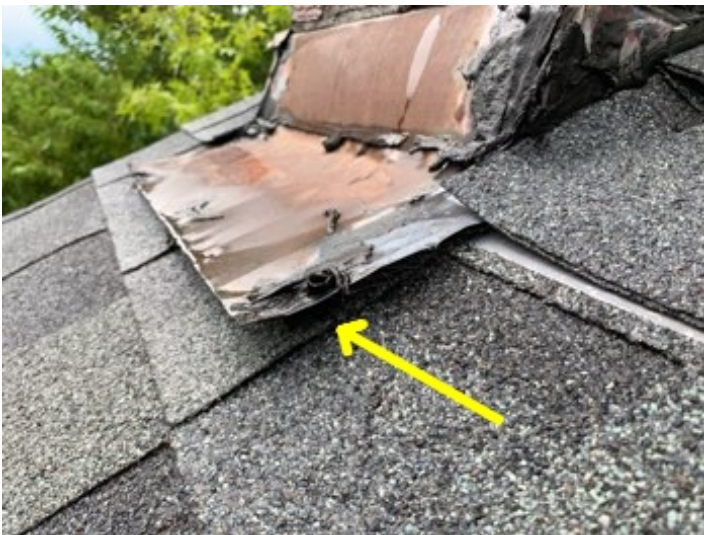
REPAIR- The chimney flashing appears to be insufficient. This may lead to water entering the building resulting in damage to the structure and finishes as well as aid in the growth of mold. Recommend contacting a licensed roofing contractor to assess and repair as needed.

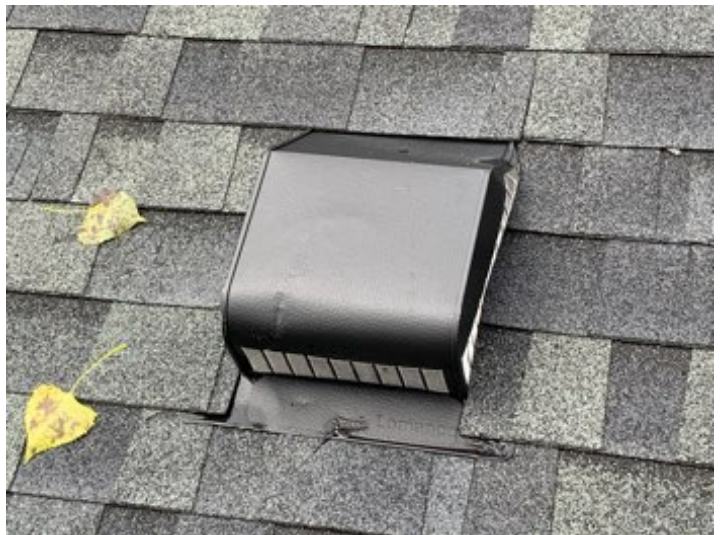
All roof vents and flashing appear in good condition.

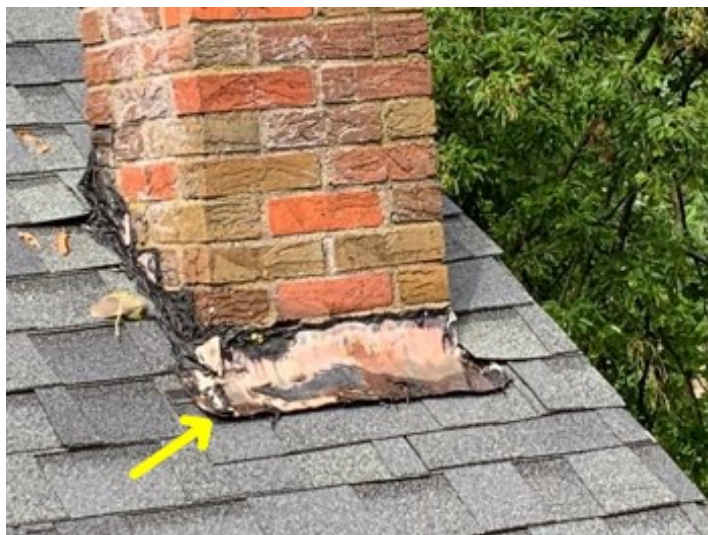
REPAIR- The chimney flashing appears to be insufficient. This may lead to water entering the building resulting in damage to the structure and finishes as well as aid in the growth of mold. Recommend contacting a licensed roofing contractor to assess and repair as needed.

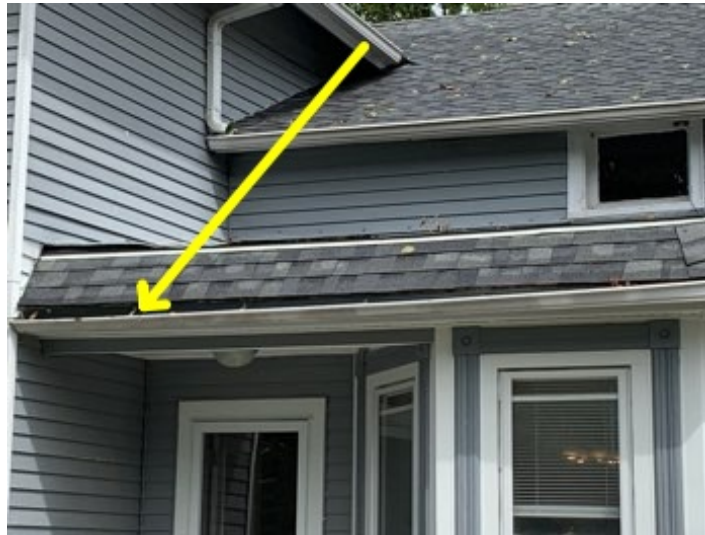
REPAIR - The front gutter appears to be poorly installed. Improper drainage may lead to water collection and intrusion at the foundation. Recommend contacting an appropriate reputable contractor to assess and repair as needed.

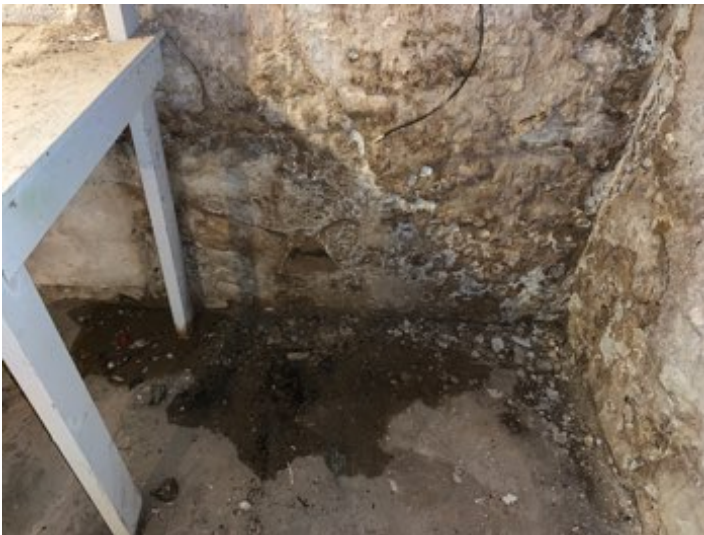
REPAIR- Water/moisture intrusion observed. Water may damage building finishes and structural components as well as aid in the growth of mold. Recommend contacting an appropriate reputable contractor to assess and repair as needed.

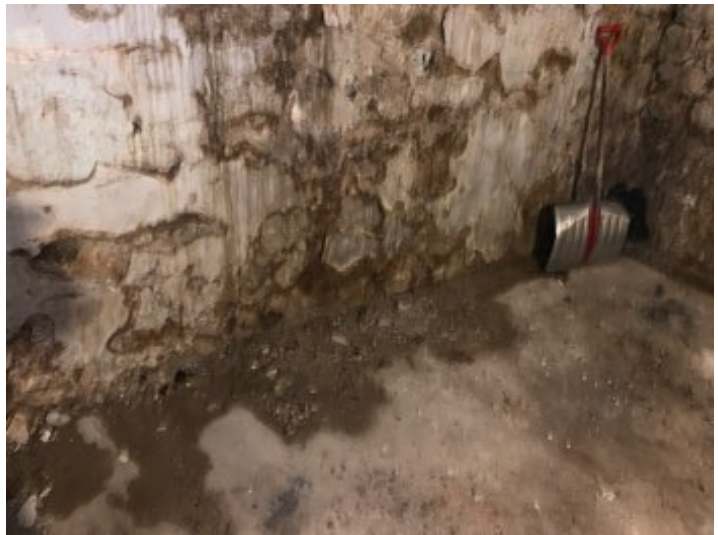
REPAIR- Water/moisture intrusion observed. Water may damage building finishes and structural components as well as aid in the growth of mold. Recommend contacting an appropriate reputable contractor to assess and repair as needed.

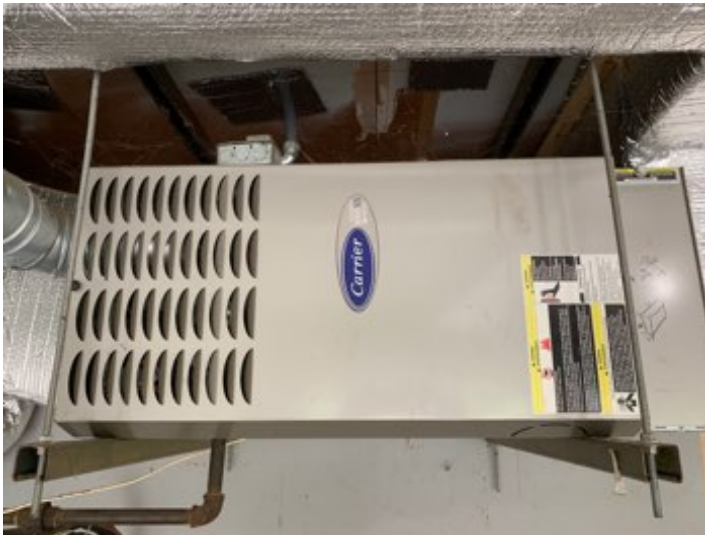
Carrier brand medium efficient furnace

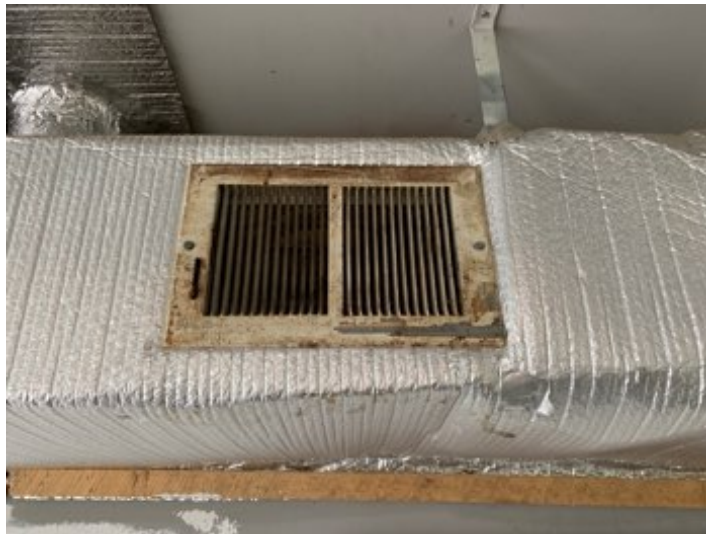
REPAIR - Supply register observed in the garage. This is considered less safe. Fire and carbon monoxide could enter into the home through the duct work. Recommend contacting a reputable HVAC contractor to assess and repair as needed.

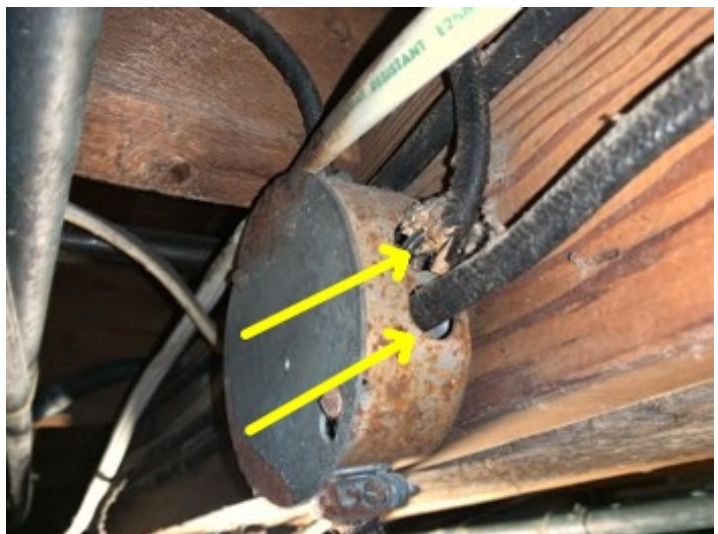
REPAIR - Junction box in the basement were not properly covered. This is improper and less safe. Recommend contacting a certified electrical contractor to assess and repair as needed.

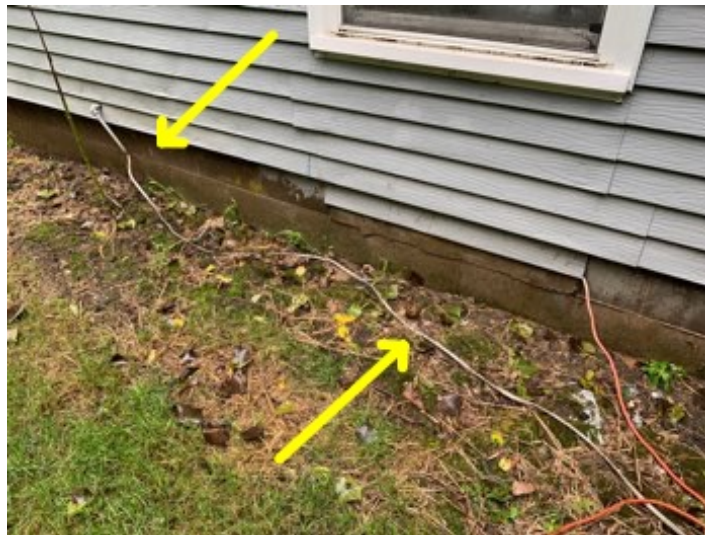
REPAIR - Electrical cables not protected inside conduit observed outside. This is improper and less safe. Recommend contacting a certified electrical contractor to assess and repair as needed.

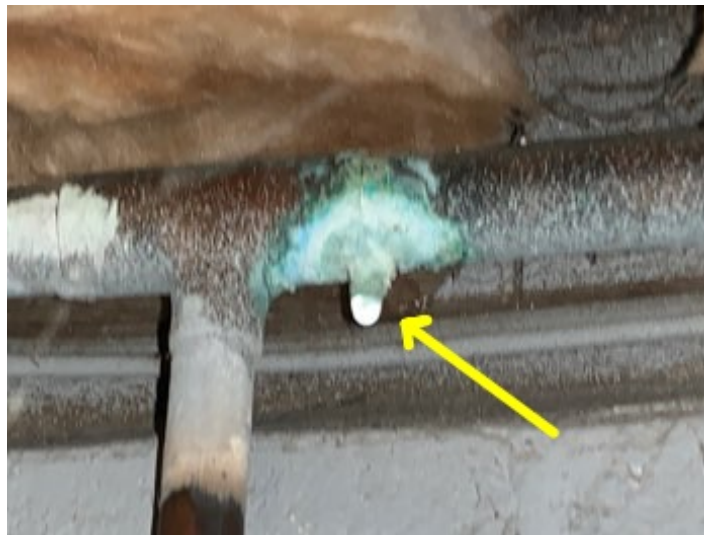
REPAIR - Water supply branch pipe in the basement laundry area north wall observed leaking. Water leaks may lead to damage to the structure and finishes of the home as well aid in the growth of mold. Recommend contacting a reputable licensed plumbing contractor to assess and repair as needed.

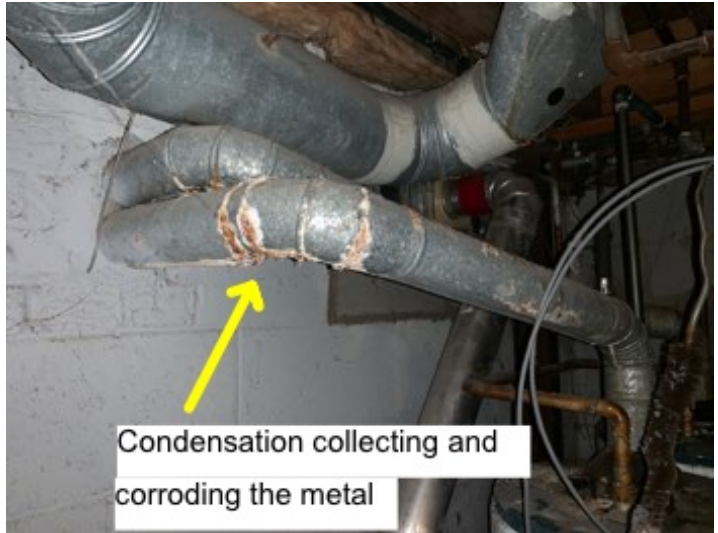
Condensation collecting and
corroding the metal

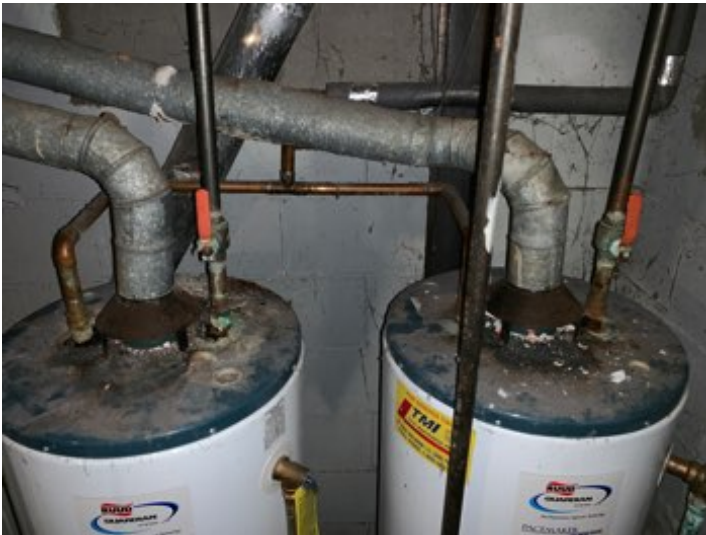
REPAIR - The exhaust vents had an improper slope. This may affect the performance of the unit as well as allow carbon monoxide to back up into the home. Recommend contacting a reputable licensed plumbing contractor to assess and repair as needed.
