Insight Home Inspections

Property Inspection Report

1111 Sample Report Blvd, Davenport, IA 52807
Inspection prepared for: Sample Report
Date of Inspection: 1/1/2019 Time: 8:00am
Age of Home: Built in 2007 Size: 3910 Finished Square Feet

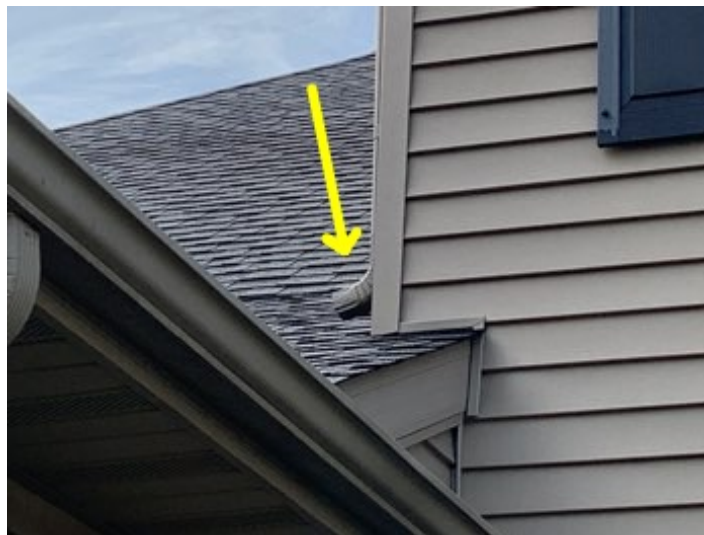
REPAIR - The front upper roof line gutter down spout spills directly onto the roof surface. This wears down the shingles and is considered an improper installation. Recommend contacting an appropriate reputable contractor to assess and repair as needed.

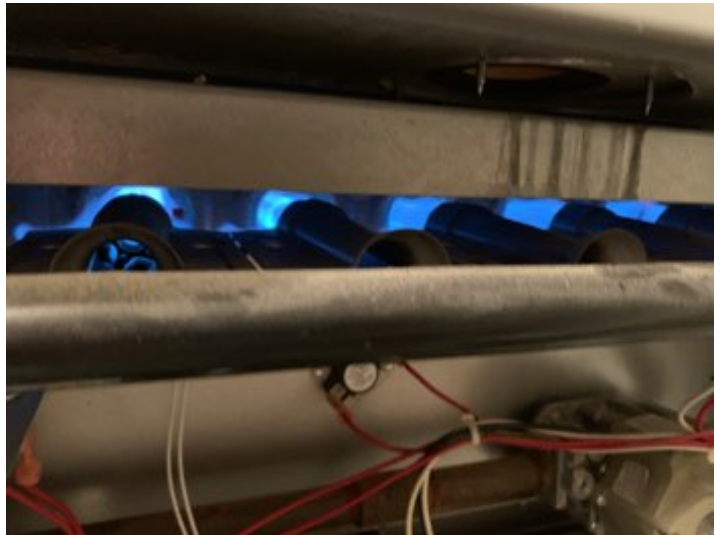
Flames burn bright blue indicating proper fuel combustion.

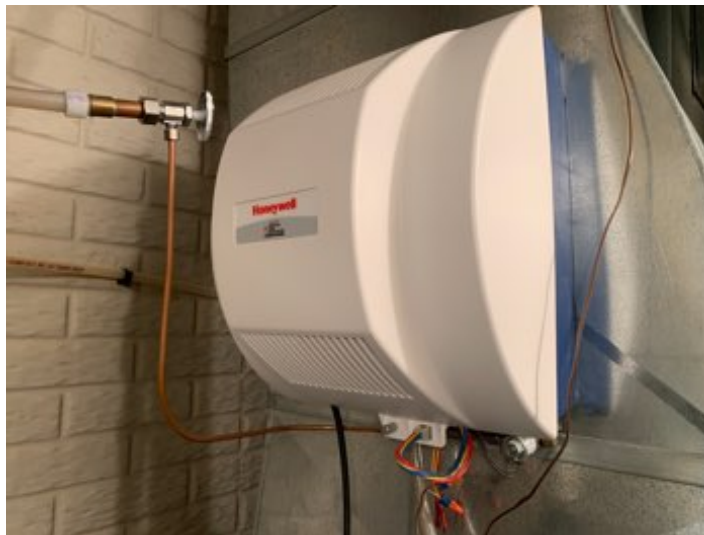
INFORMATION - Humidifiers require routine annual service prior to each heating season. This should be part of annual/seasonal HVAC service contract. If not serviced bacteria can grow and be introduced into the home through the humidifier and ductwork.

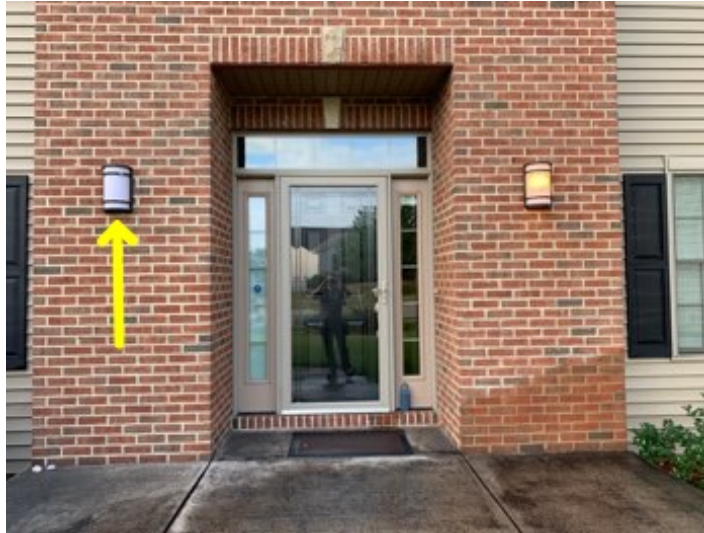
REPAIR- The front exterior light fixture did not work. Recommend contacting a certified electrical contractor to assess and repair as needed.

REPAIR- The basement "entry" lights 3-way switches were not working properly. The light should turn on and off at both switches with each flip of the switch. This was not the case and is considered an improper wiring practice. Recommend contacting a certified electrical contractor to assess and repair as needed.

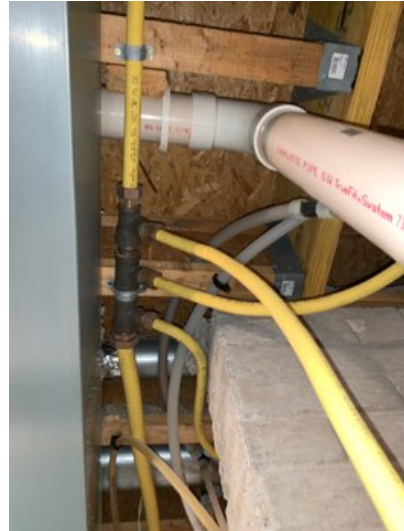
REPAIR - Corrugated Stainless Steel Tubing (**CSST**) was present with no proper bonding to the grounding electrode, electrical service equipment enclosure, or the grounded conductor at the electrical service. This may lead to damage and fire from a lightning strike near or to the home. Recommend contacting a reputable electrical contractor to properly bond the CSST.

REPAIR - Corrugated Stainless Steel Tubing (CSST, yellow coating) was present with no proper bonding to the grounding electrode, electrical service equipment enclosure, or the grounded conductor at the electrical service. This may lead to damage and fire from a lightning strike near or to the home. Recommend contacting a reputable electrical contractor to properly bond the CSST.

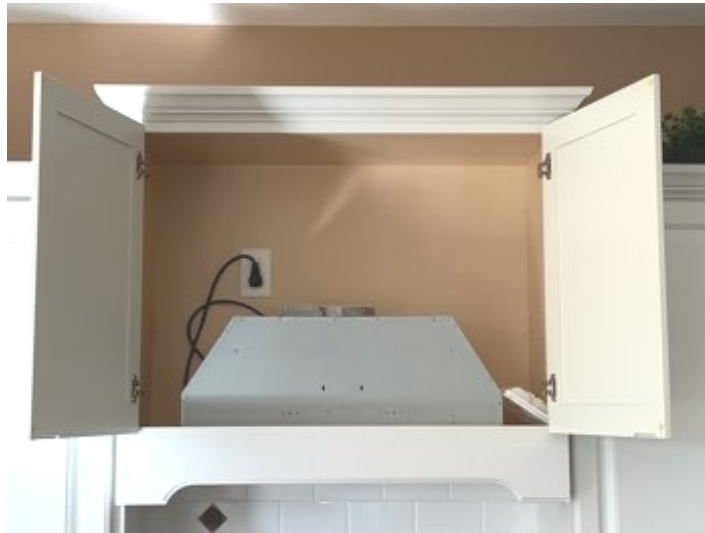
REPAIR - The unit did not properly vent to the exterior. Recommend contacting an appropriate reputable contractor to assess and repair as needed.
