Insight Home Inspections

Property Inspection Report

123 Sample Report Drive, Moline, IL 61265
Inspection prepared for: Sample Report
Date of Inspection: 1/1/2019 Time: 8am
Age of Home: Built in 1835 Size: 3322 Finished Square Feet

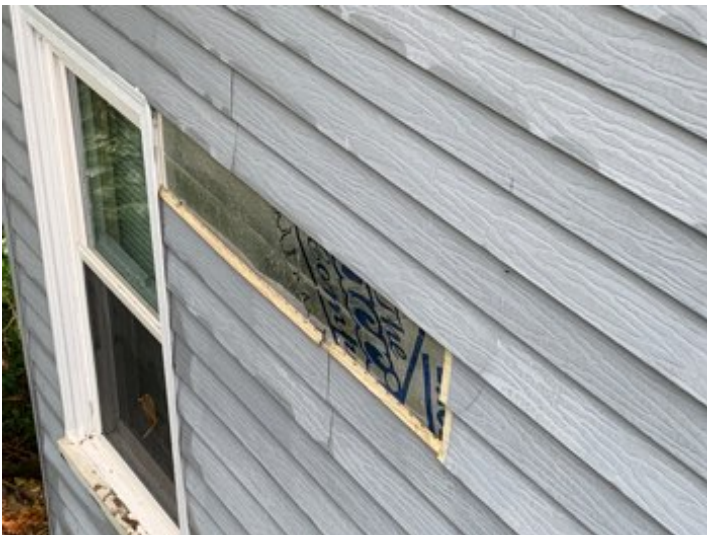
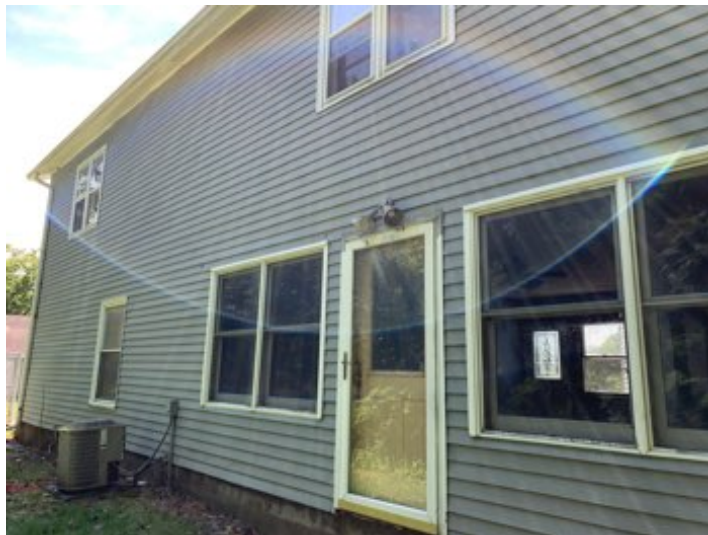
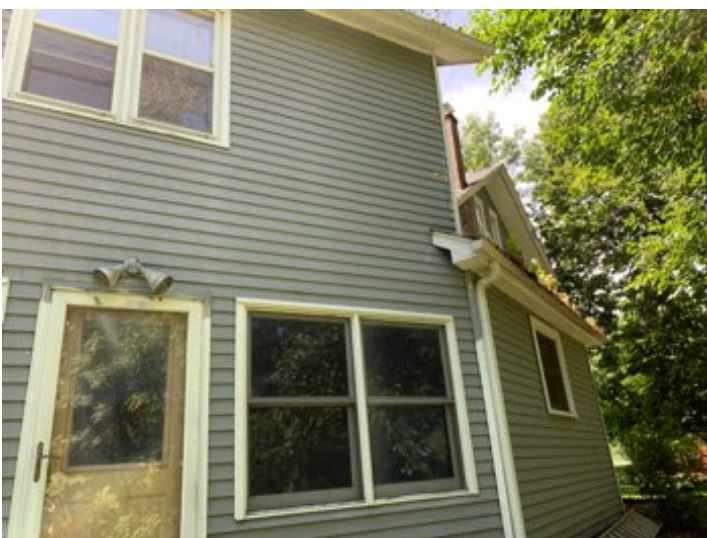
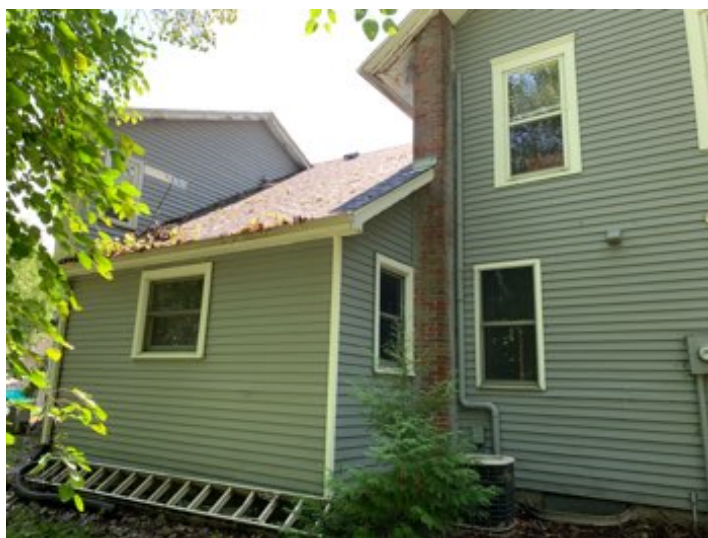
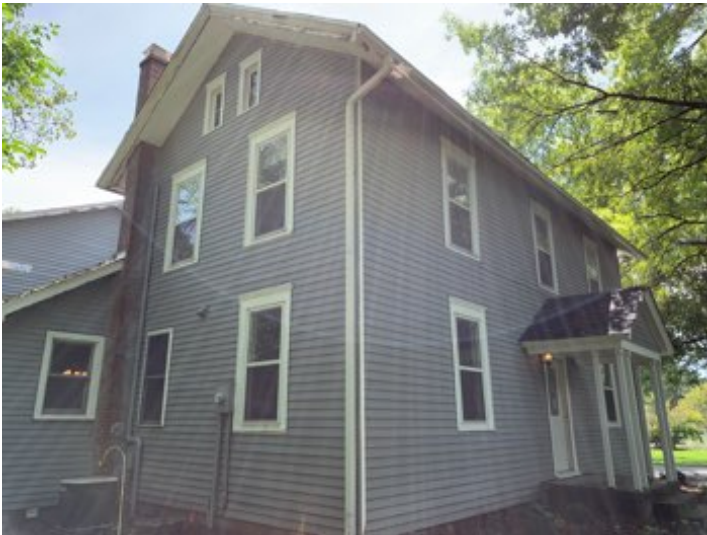
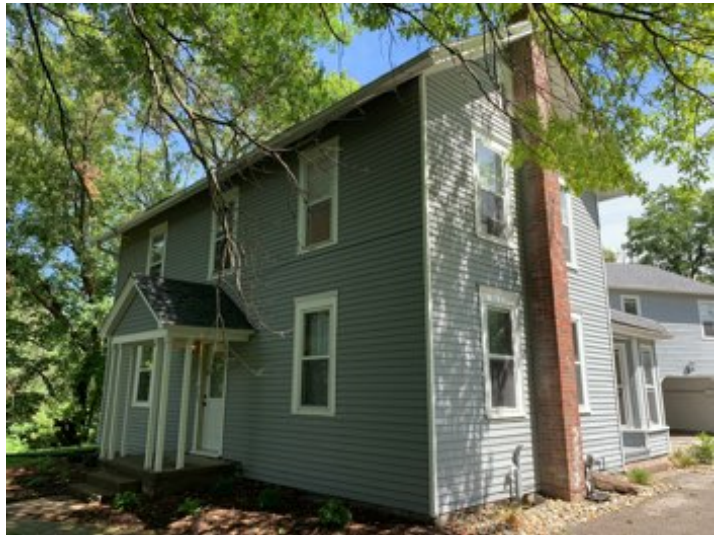
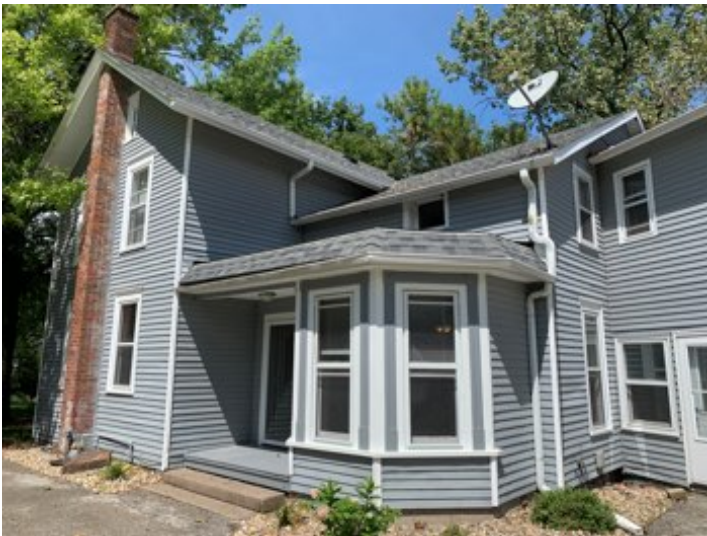
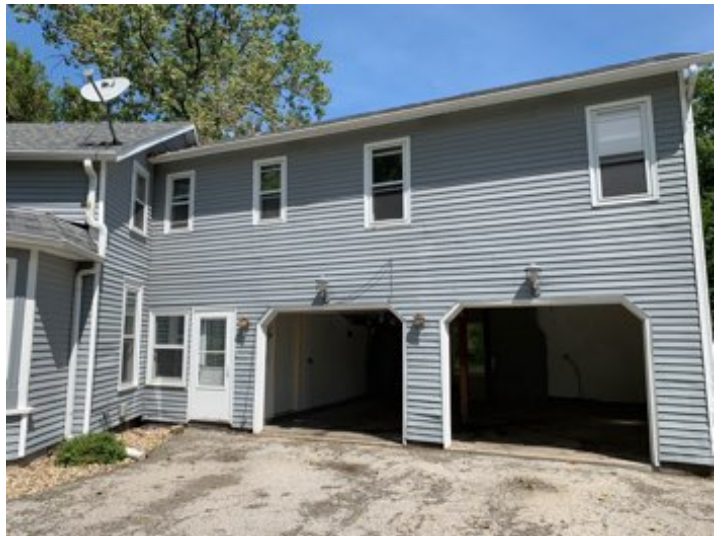
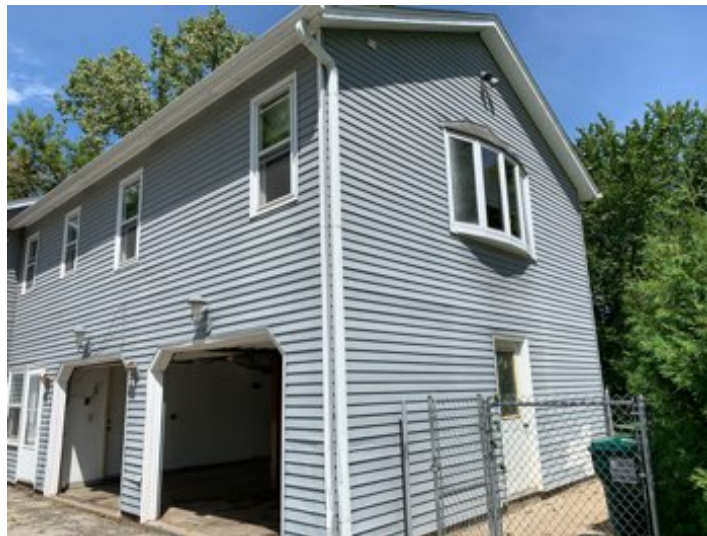
REPAIR- Areas of siding observed missing. This may allow water to enter the building. Recommend contacting an appropriate reputable contractor to assess and repair as needed.

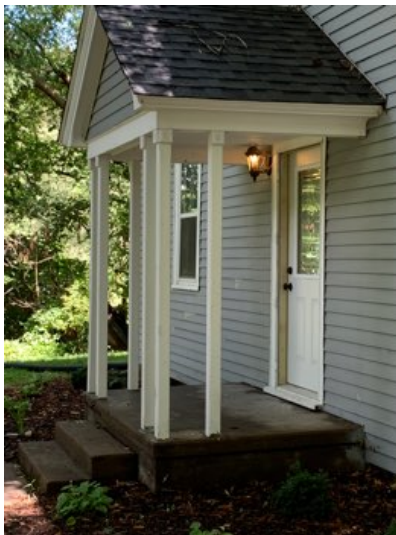
Appeared satisfactory. No significant damage, deterioration or deficiencies observed during the inspection.

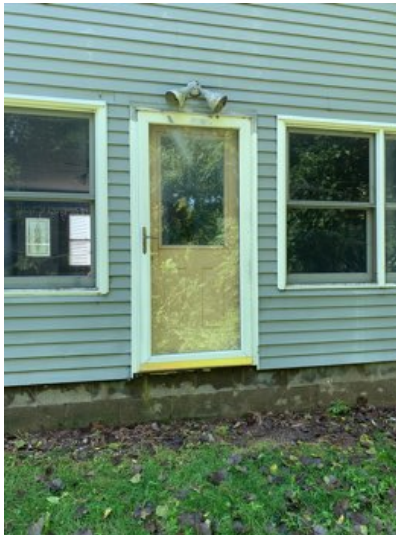
REPAIR - The back door was more than 12 inches off of the ground level and did not have steps at the exterior. This is less safe. Recommend contacting a reputable contractor to assess and repair as needed.

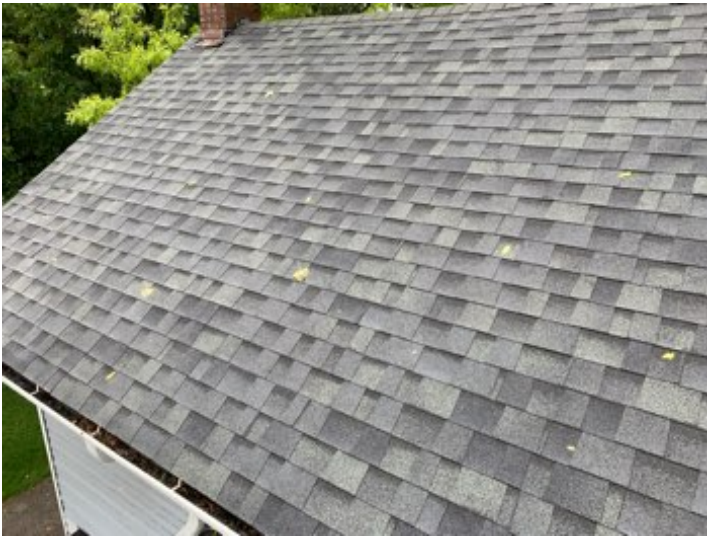
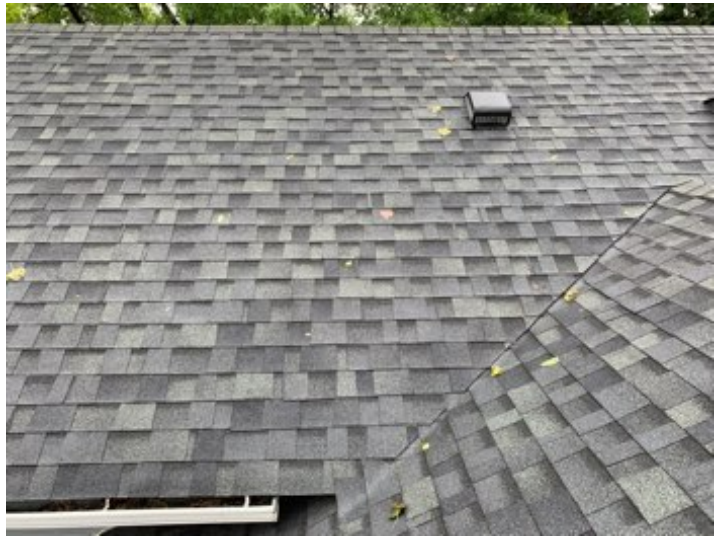
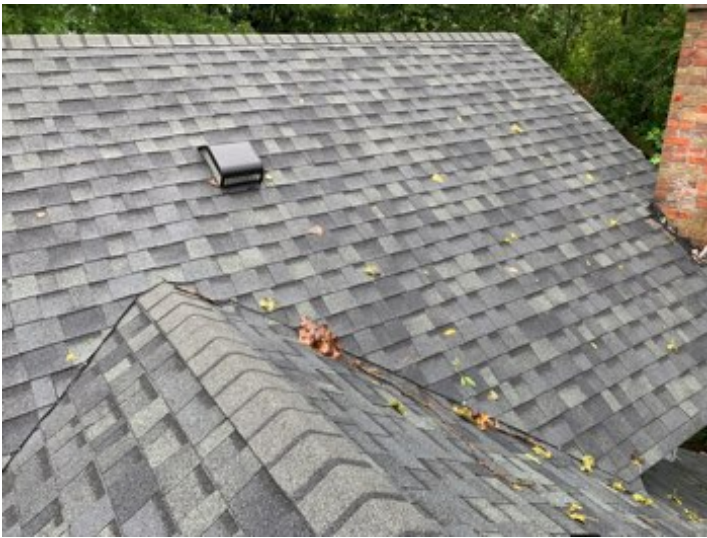
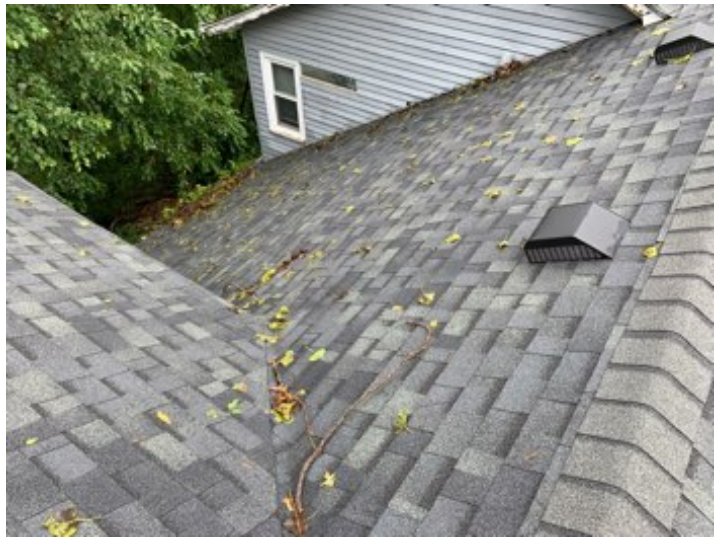
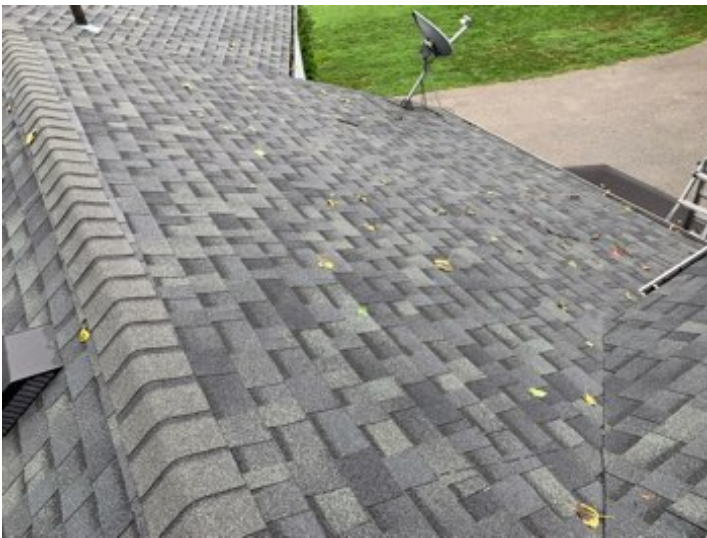
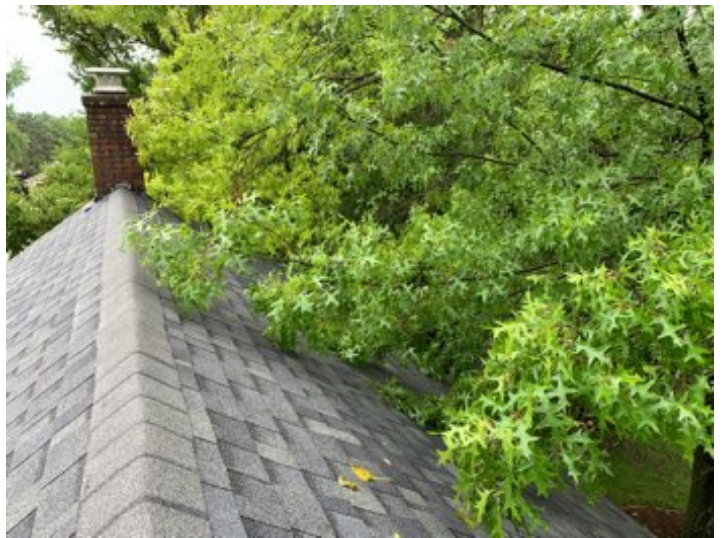
MAINTENANCE - One or more tree's branches were touching the roof surface. This may wear down the roof surface as well as trap moisture allowing it to seep into the structure resulting in damage to the structure as well as encourage mold growth. Recommend trimming the branches back off of the roof by a qualified professional.

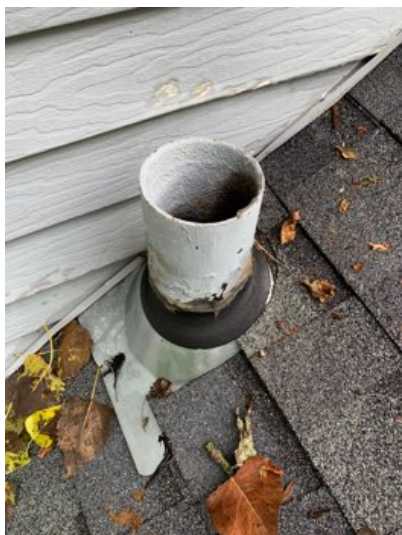
Plumbing stack and flashing appear in good condition.

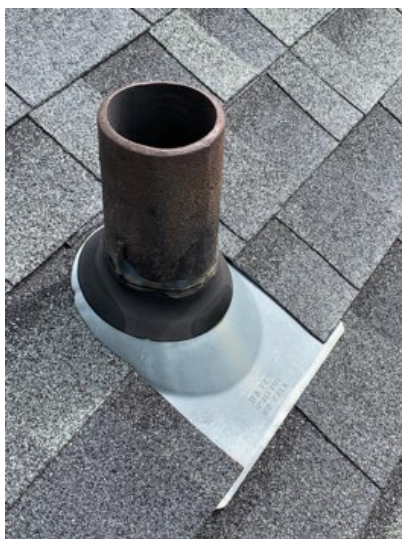
Plumbing stack and flashing appear in good condition.

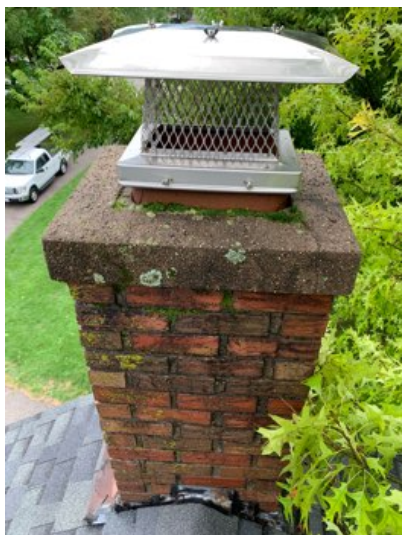
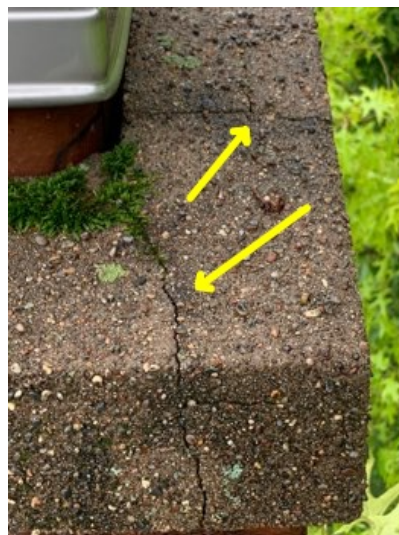
REPAIR- Cracks observed in one or more chimney's crown. This may allow water to enter and damage the flue and chimney. Recommend contacting an appropriate reputable contractor to assess and repair as needed.

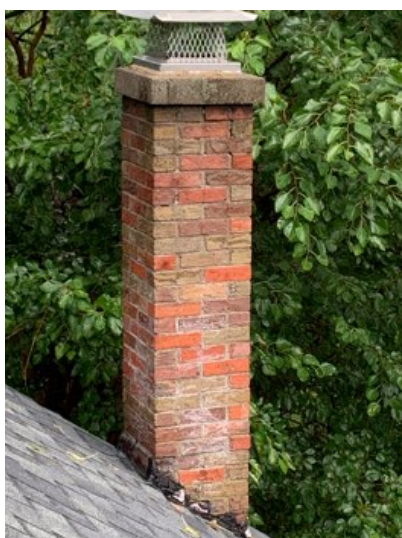
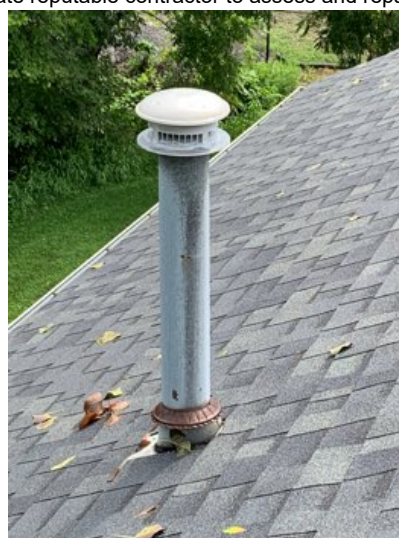
REPAIR- Cracks observed in one or more chimney's crown. This may allow water to enter and damage the flue and chimney. Recommend contacting an appropriate reputable contractor to assess and repair as needed.

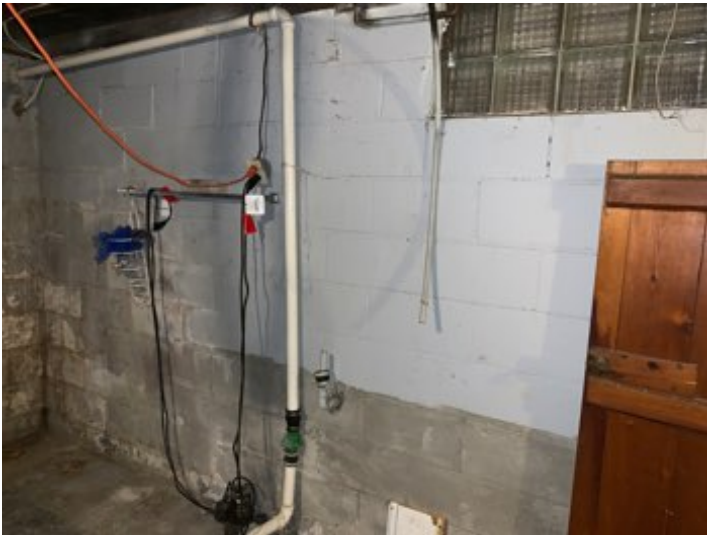
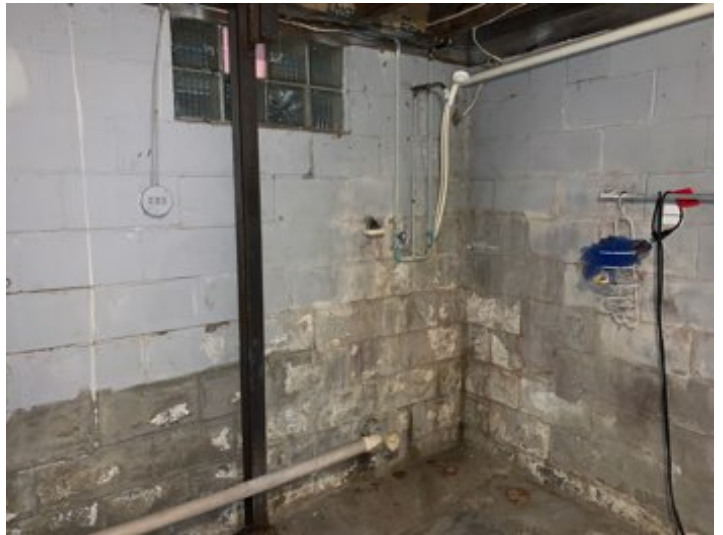
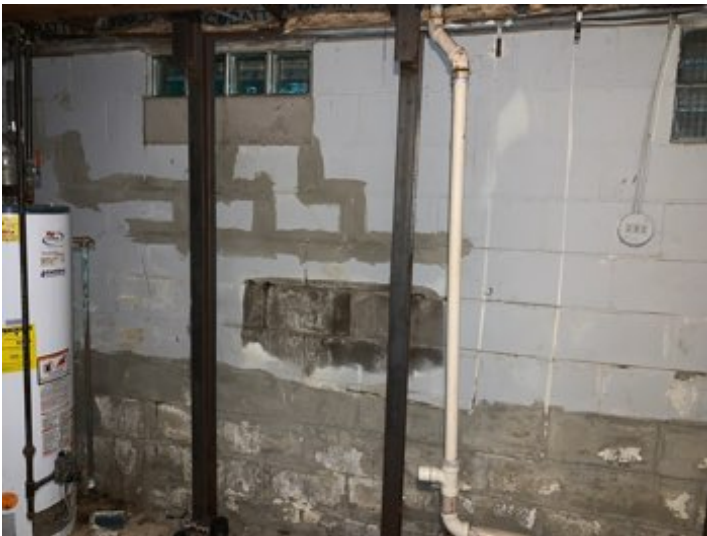
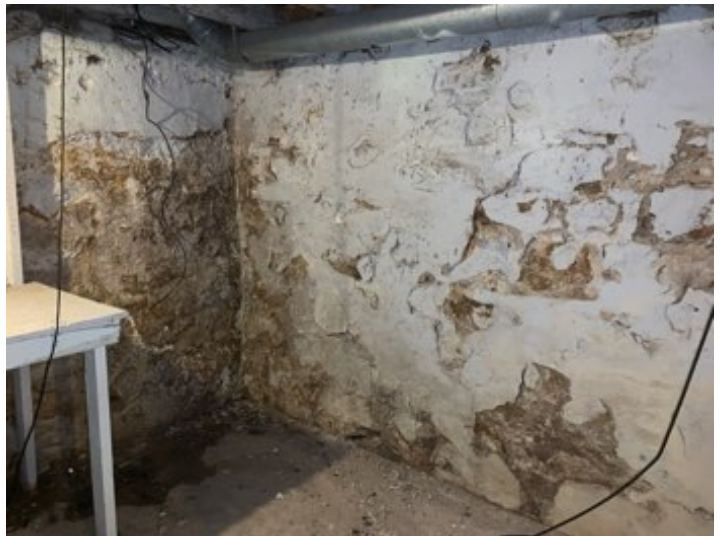
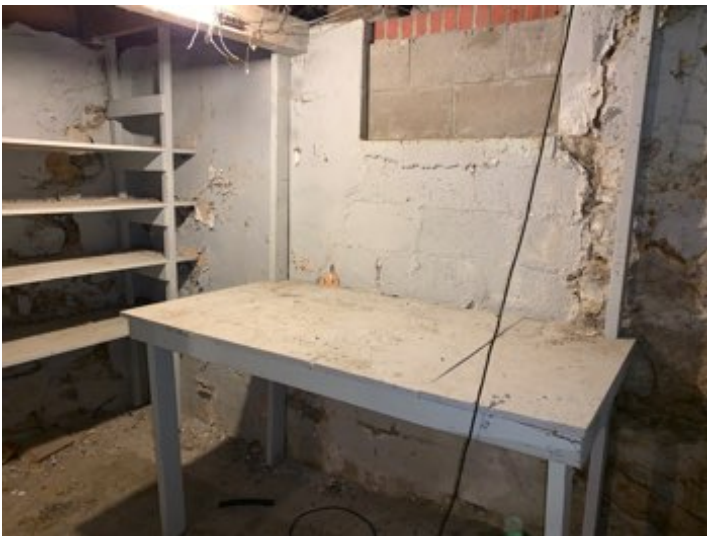
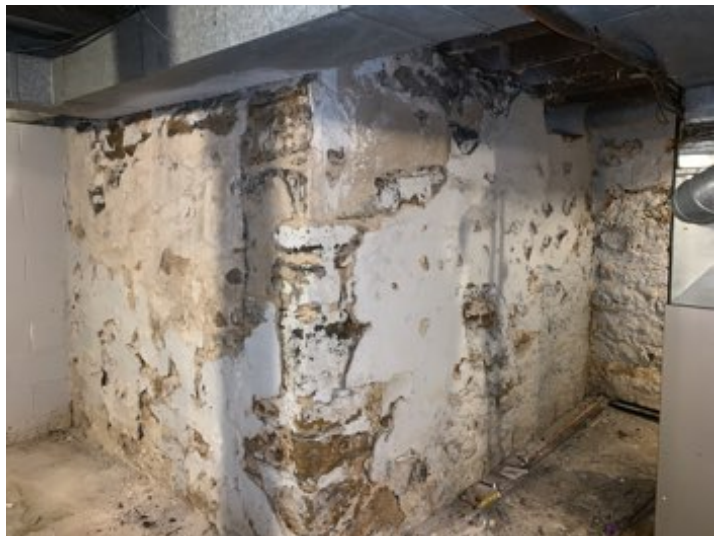
Page 15 Item: 2	Foundation	REPAIR- Water/moisture intrusion observed. Water may damage building finishes and structural components as well as aid in the growth of mold. Recommend contacting an appropriate reputable contractor to assess and repair as needed.
-----------------	------------	--

REPAIR- Water/moisture intrusion observed. Water may damage building finishes and structural components as well as aid in the growth of mold. Recommend contacting an appropriate reputable contractor to assess and repair as needed.

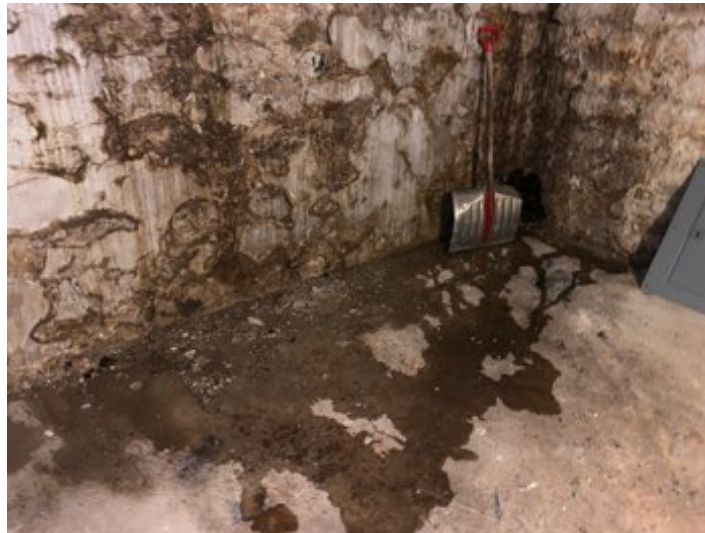
REPAIR- Water/moisture intrusion observed. Water may damage building finishes and structural components as well as aid in the growth of mold. Recommend contacting an appropriate reputable contractor to assess and repair as needed.

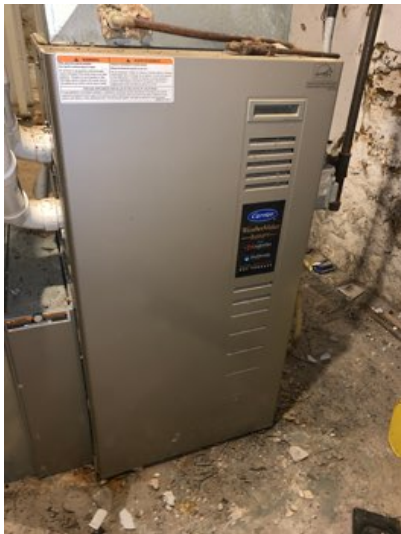
Carrier brand high efficient furnace.

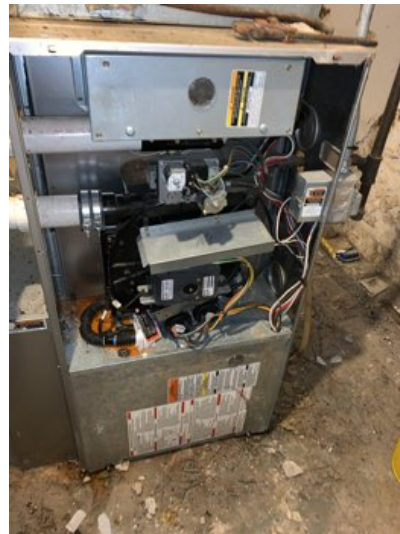
Interior of furnace cabinet: no deficiencies observed.

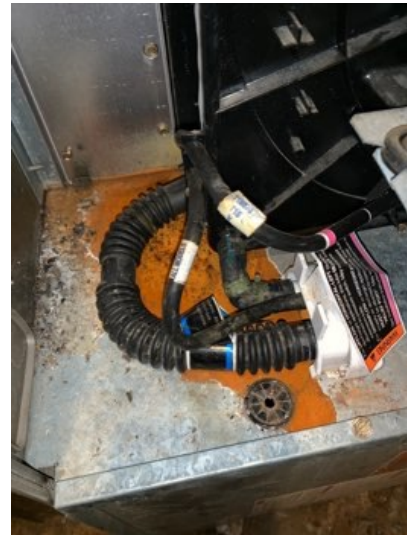
INFORMATION - Indications of a condensation leak observed in the basement furnace cabinet. It could not be determined if this an active or a corrected leak. Recommend contacting a reputable HVAC contractor to assess and repair as needed

INFORMATION - Indications of a condensation leak observed. It could not be determined if this is an active or a corrected leak. Recommend contacting a reputable HVAC contractor to assess and repair as needed

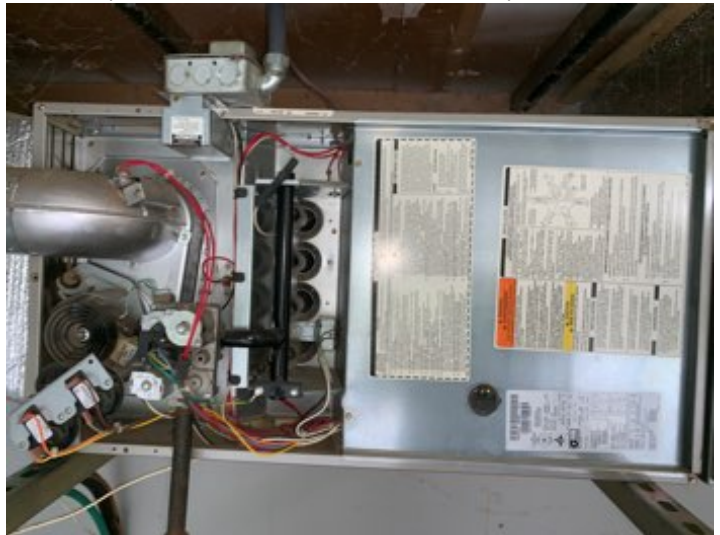
Interior of furnace cabinet: no deficiencies observed.

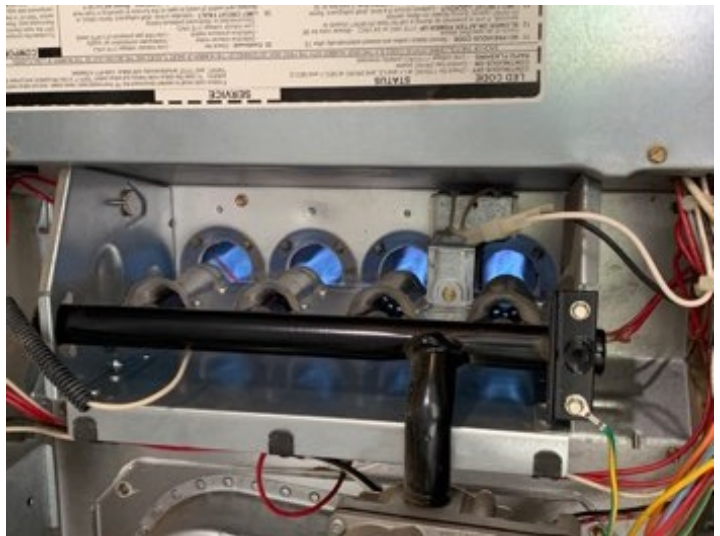
Flames burn bright blue indicating proper fuel combustion (garage unit).

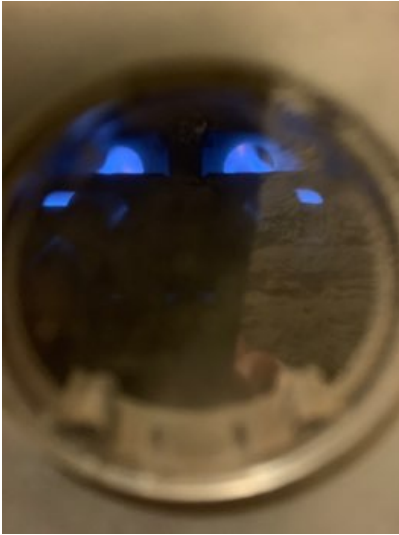
Flames burn bright blue indicating proper fuel combustion (basement unit).

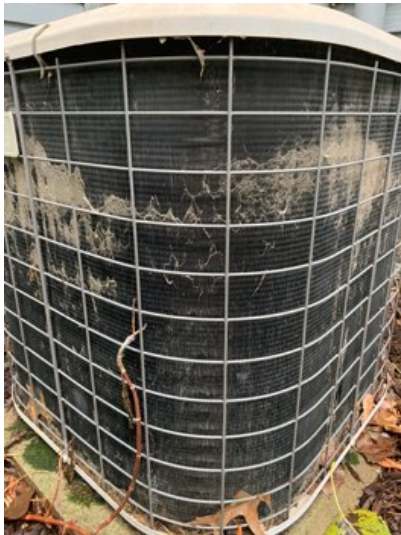
MAINTENANCE - The exterior coil was dirty and needs cleaned. Keeping the coil clean will help with efficiency and help prevent premature failure. Recommend cleaning the coil upon possession of the home and annually thereafter.

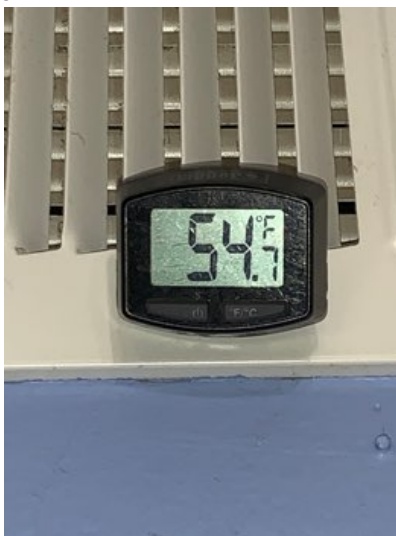
Supply air temperature from Payne A/C unit

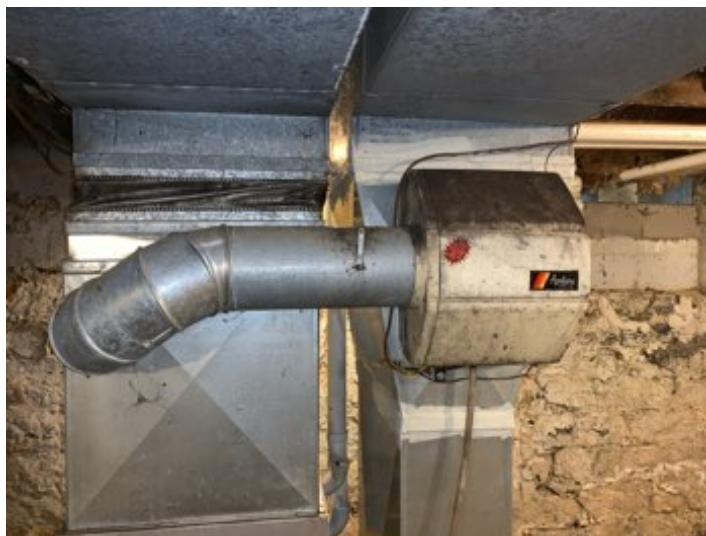
INFORMATION - Humidifiers require routine annual service prior to each heating season. This should be part of annual/seasonal HVAC service contract. If not serviced bacteria can grow and be introduced into the home through the humidifier and ductwork.

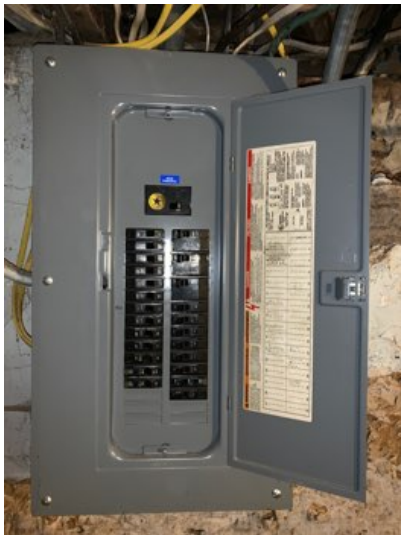
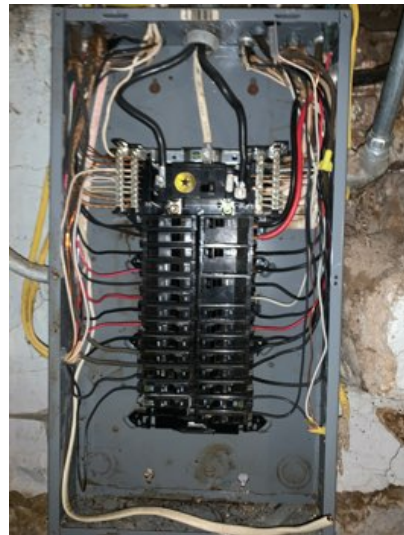
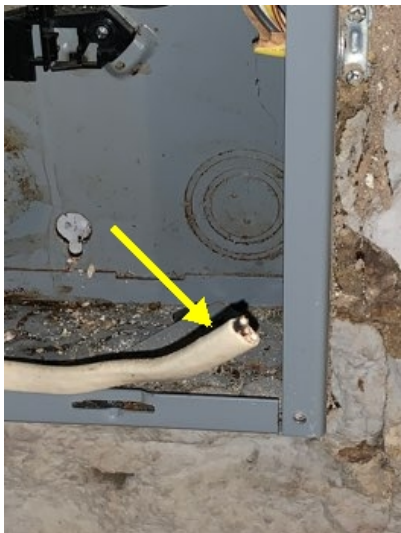
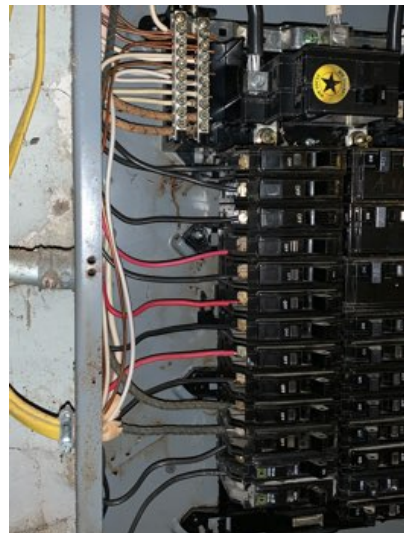
REPAIR- One or more wires in the panel were not terminated properly. This is considered less safe. Recommend contacting a certified electrical contractor to assess and repair as needed.

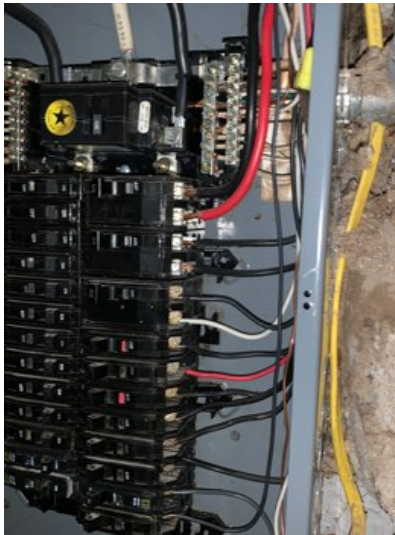
Right side breakers and neutral bus bar: no deficiencies observed.

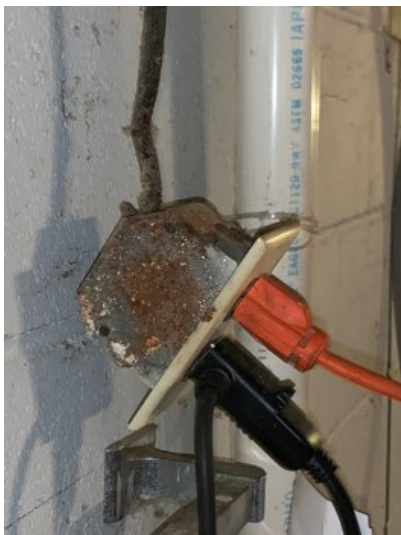
REPAIR - The sump pump and garage receptacles were not secured to the structure. This is considered less safe. Recommend contacting a certified electrical contractor to assess and repair as needed.

REPAIR - The sump pump receptacle was not secured to the structure. This is considered less safe. Recommend contacting a certified electrical contractor to assess and repair as needed.

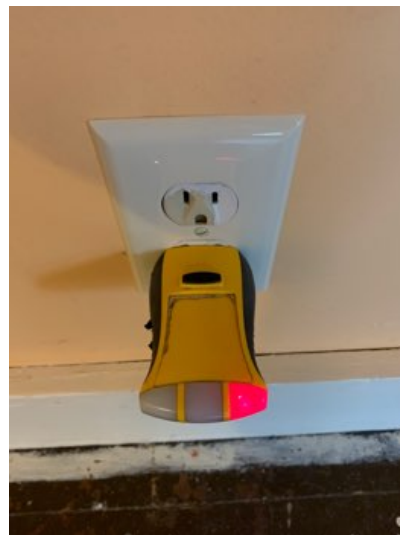
REPAIR - Multiple grounded (3 prong) receptacles read on the test meter to be not grounded. This is improper and less safe. Recommend contacting a certified electrical contractor to assess and repair as needed.

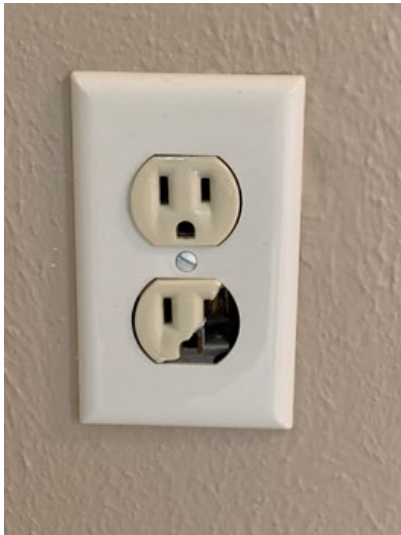
REPAIR - Damaged receptacle observed in SW bedroom. This is less safe. All electrical components should be undamaged and in proper working condition. Recommend contacting a certified electrical contractor to assess and repair as needed.

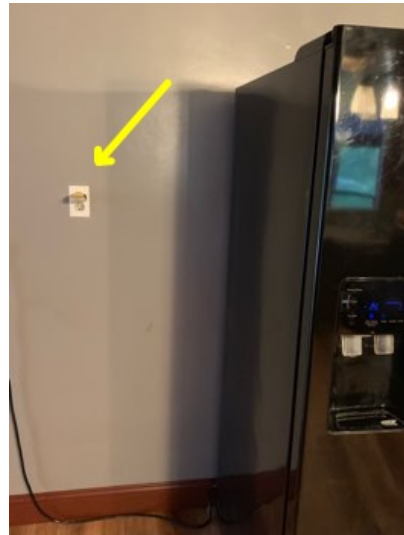
REPAIR - The kitchen receptacle left of the refrigerator did not work. Recommend contacting a certified electrical contractor to assess and repair as needed.

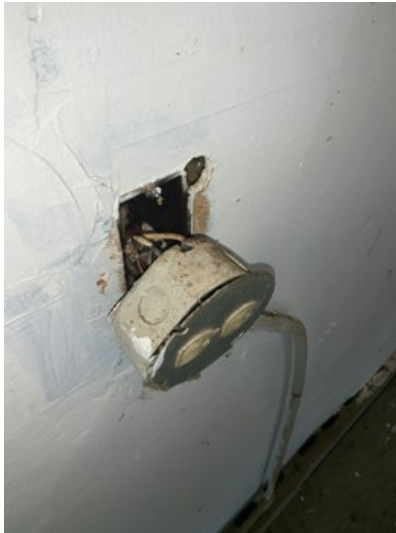
REPAIR - The garage receptacle was not secured to the structure. This is considered less safe. Recommend contacting a certified electrical contractor to assess and repair as needed.

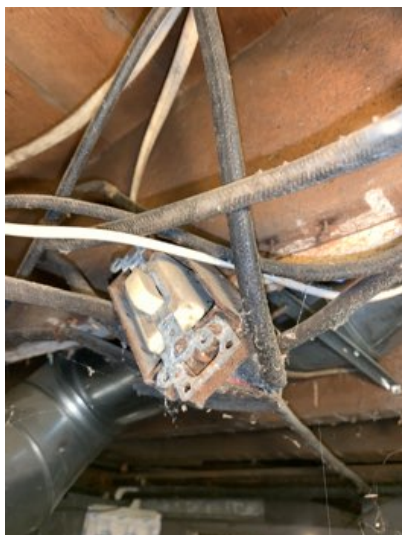
REPAIR - Basement switch located in the floor joists was not secured to the structure. This is an improper installation and less safe. Recommend contacting a certified electrical contractor to assess and repair as needed.

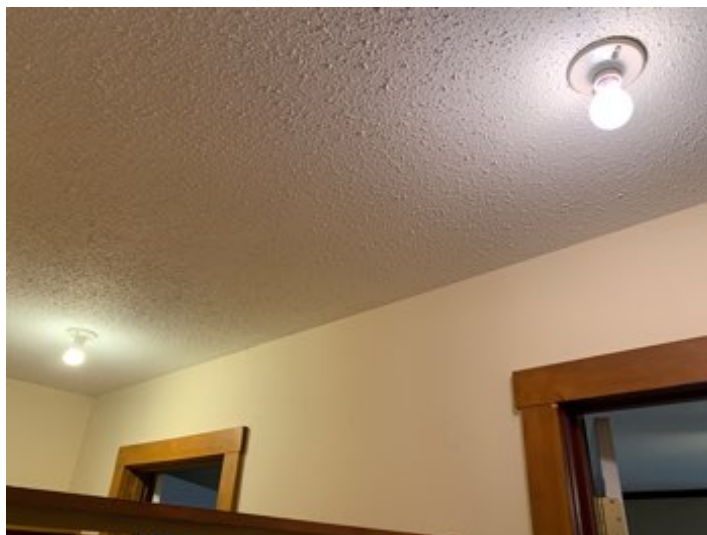
REPAIR - Multiple closet light fixtures were an exposed light bulb type. This is less safe. Recommend contacting a licensed electrical contractor to assess and repair as needed.

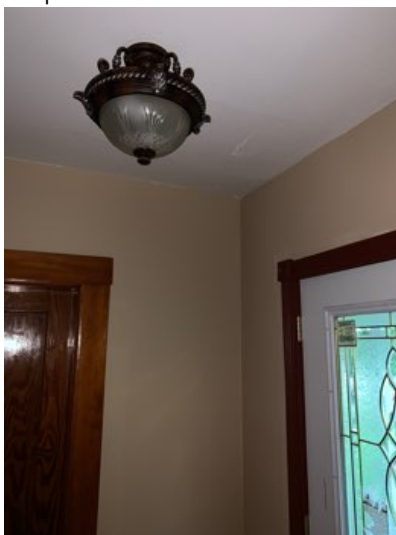
REPAIR- The side door interior entry light fixture was not working. Recommend contacting a certified electrical contractor to assess and repair as needed.

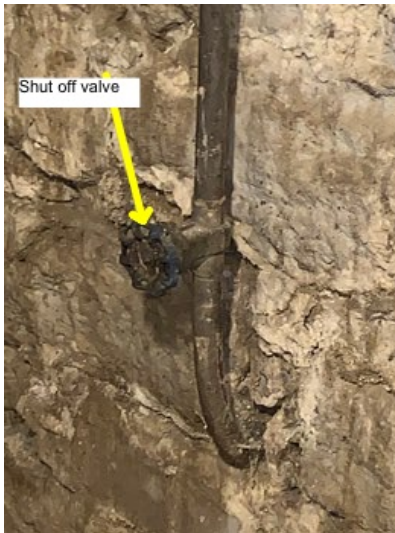
Water supply and whole house shut off valve.

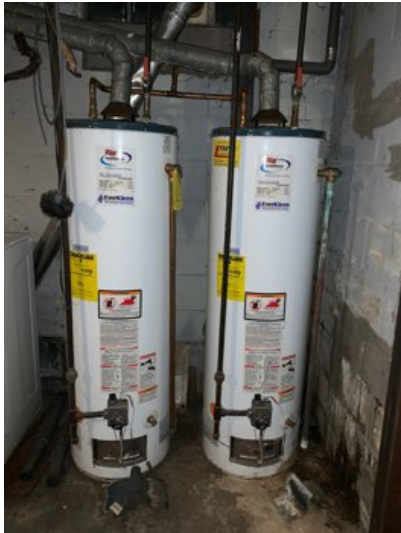
RUUD brand water heaters

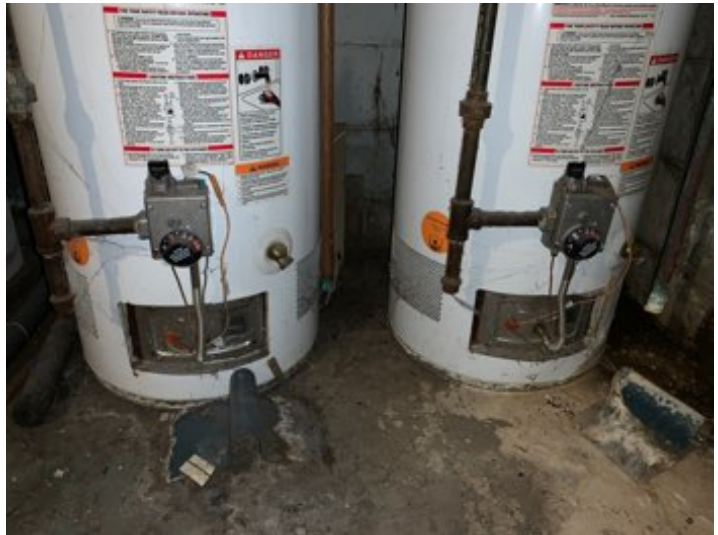
Bases of water heaters: no leaks, corrosion or damage observed

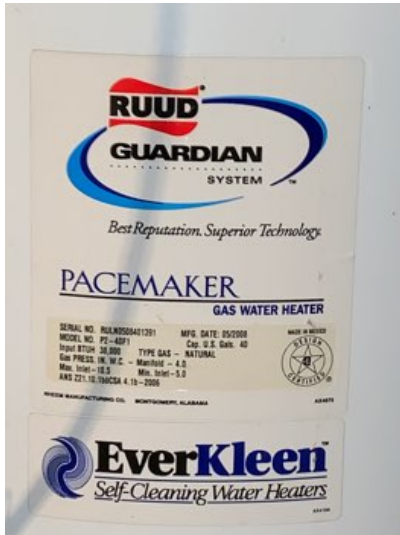
Water heater data plate with information and specifications

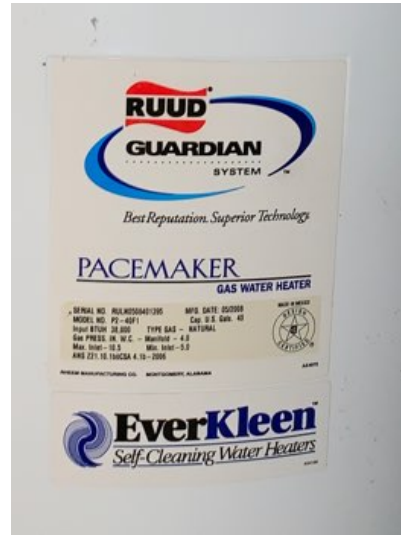
Water heater data plate with information and specifications

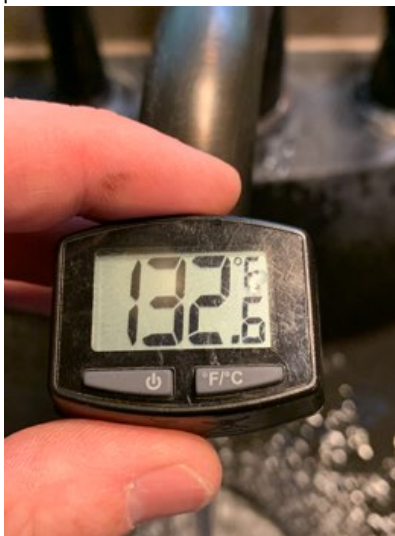
RECOMMENDATION - The hot water temperature was above 125 degrees Fahrenheit. Hot water temperatures of more than 124 degrees Fahrenheit can scald a person in a relatively short time. Recommend setting the hot water temperature in the range of 120 to 124 degrees Fahrenheit.

Hot water temp taken at the kitchen sink

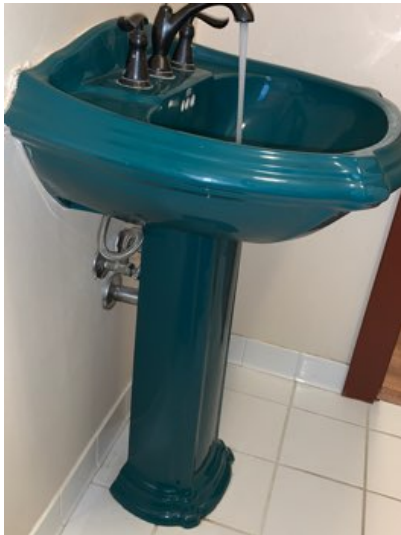
2nd floor bathroom sink: no leaks observed

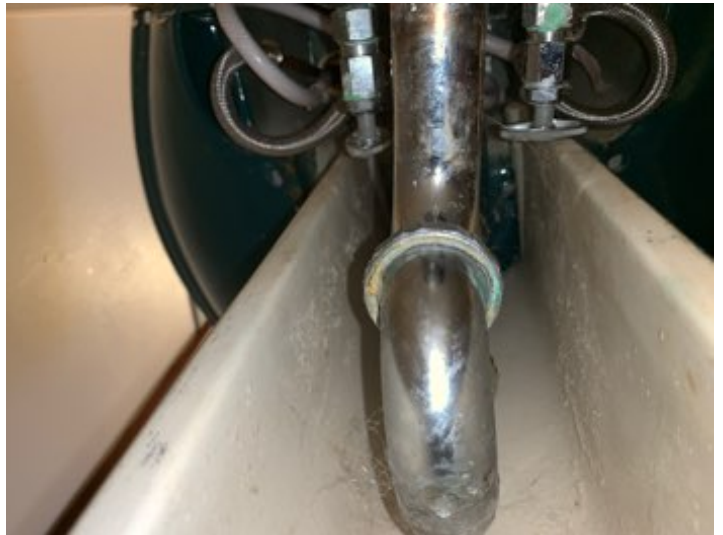
Under 2nd floor bathroom sink: no leaks observed

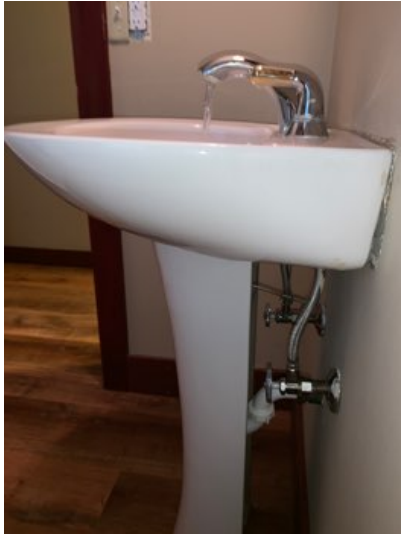
2nd floor half bathroom sink: no leaks observed

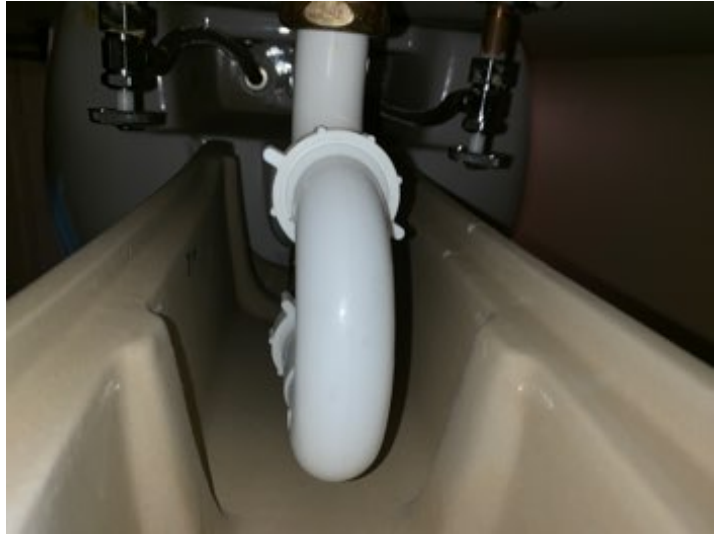
Under 2nd floor half bathroom sink: no leaks observed

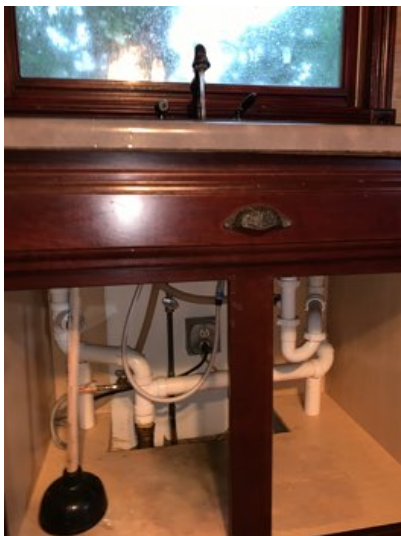
Kitchen sink: no leaks observed

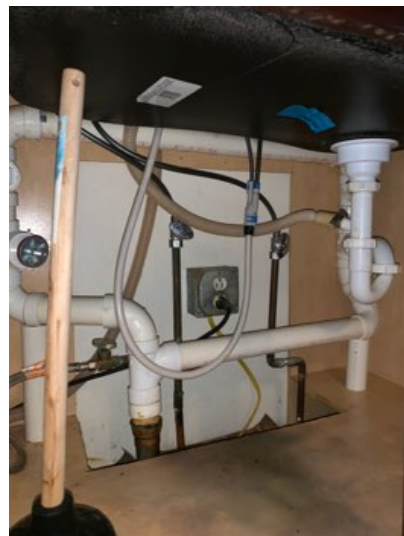
Under kitchen sink: no leaks observed

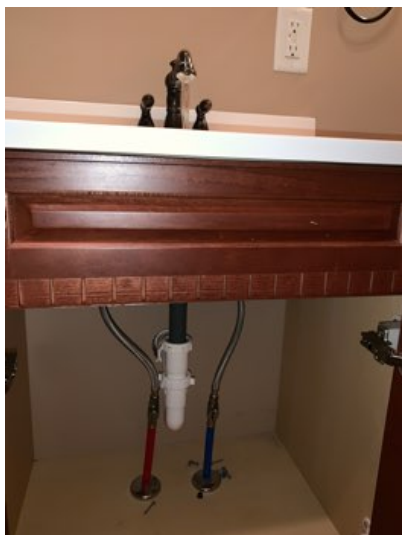
1st floor bathroom sink left: no leaks observed

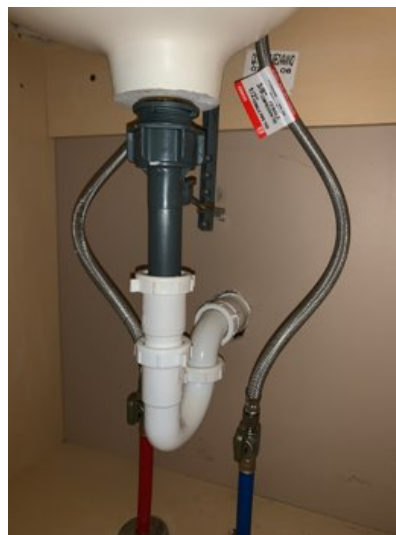
Under 1st floor bathroom sink left: no leaks observed

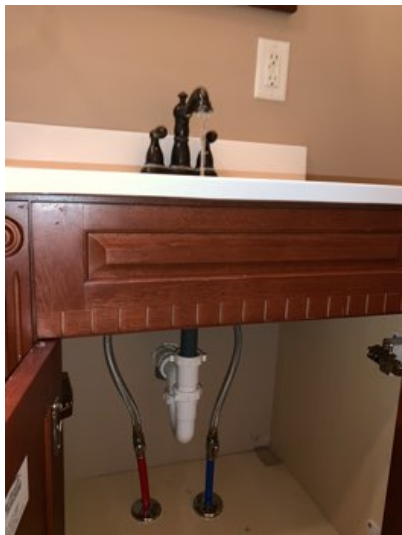
1st floor bathroom sink right: no leaks observed

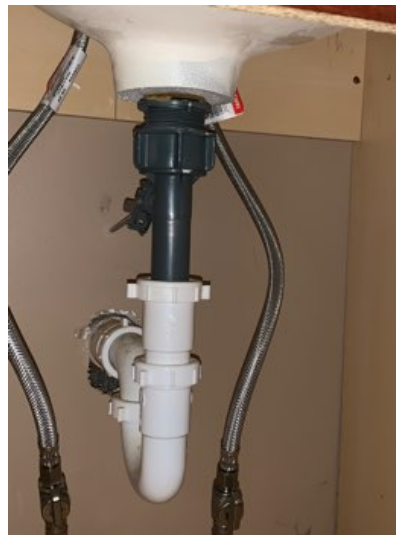
Under 1st floor bathroom sink right: no leaks observed

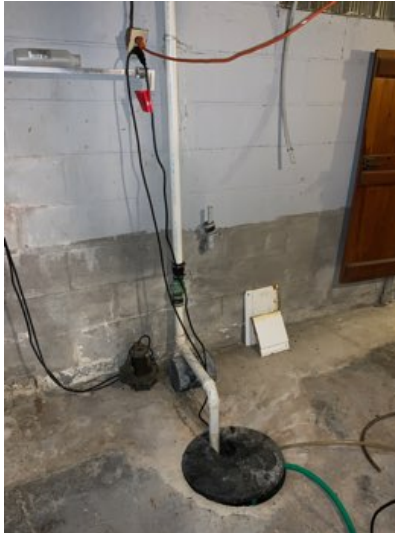
RECOMMENDATION - The sump pump was not equipped with a battery back up system. A battery back up system supplies the pump with electricity when the power company's electricity is interrupted keeping the pump on when needed. Recommend purchasing a battery back up upon possession of the home.

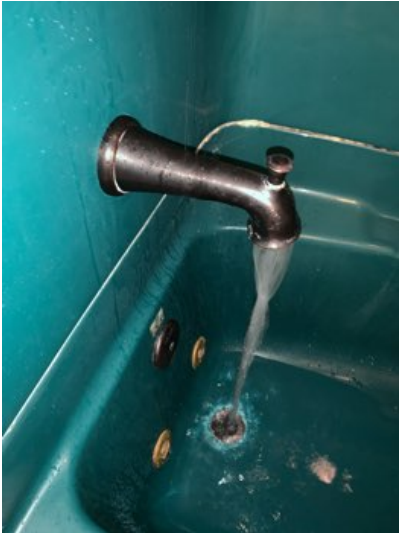
REPAIR - Loose plumbing observed (second floor tub spout). This may allow the pipes to move and leak. Water leaks may lead to damage to the structure and finishes of the home as well aid in the growth of mold. Recommend contacting a reputable licensed plumbing contractor to assess and repair as needed.

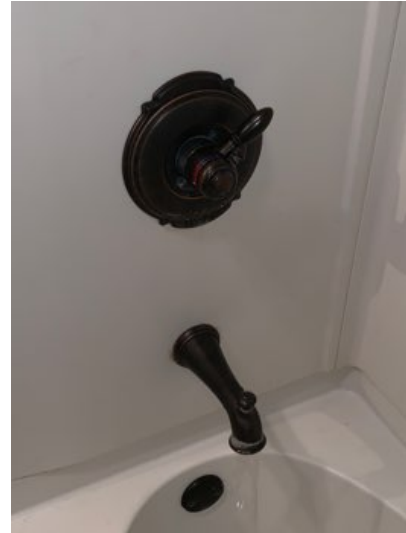
REPAIR - Loose plumbing observed (first floor tub spout and shower valve). This may allow the pipes to move and leak. Water leaks may lead to damage to the structure and finishes of the home as well aid in the growth of mold. Recommend contacting a reputable licensed plumbing contractor to assess and repair as needed.

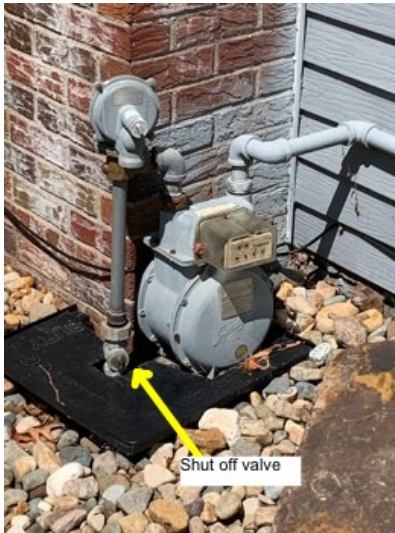
Gas supply, meter, and whole house shut off valve.

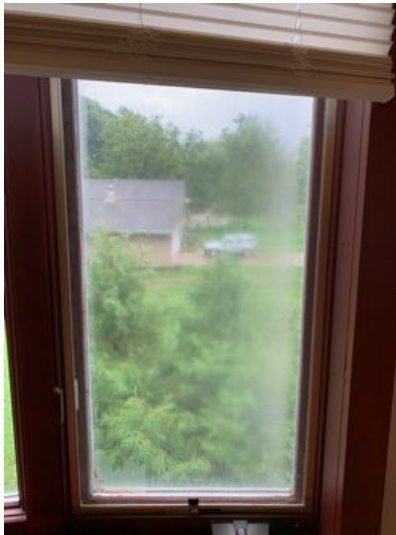
REPAIR - Fogging observed in the second floor east bedroom insulated window. Fogging occurs when the insulation seal is broken allowing the gas used for insulation to escape. The gas is replaced with air and moisture resulting in fogging and zero insulation value. Recommend contacting an appropriate reputable contractor to assess and repair as needed.

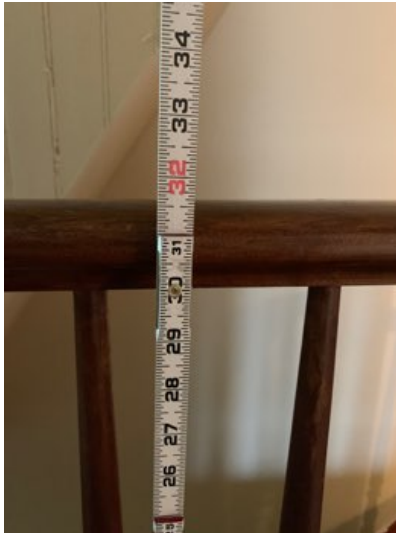
5. Stairways and Railings

REPAIR - The second floor guard rail was less than 36 inches in height. This is improper and less safe. Recommend contacting an appropriate and reputable contractor to assess and repair as needed.
