Insight Home Inspections

Property Inspection Report

123 Sample Report Drive, Moline, IL 61265
Inspection prepared for: Sample Report
Date of Inspection: 1/1/2019 Time: 8am
Age of Home: Built in 1835 Size: 3322 Finished Square Feet

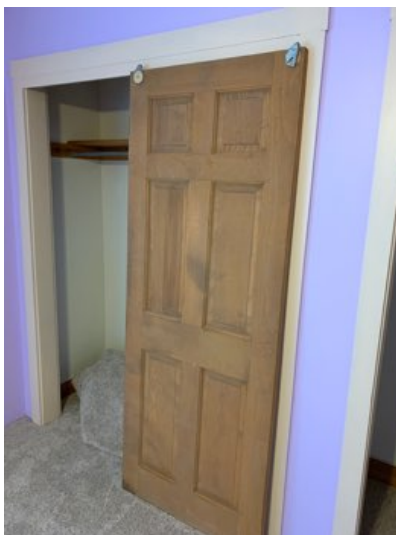
6. Interior Doors

REPAIR - The purple bedroom closet door was off track. This limits the use of the door as designed. Recommend contacting a reputable contractor to assess and repair as needed.

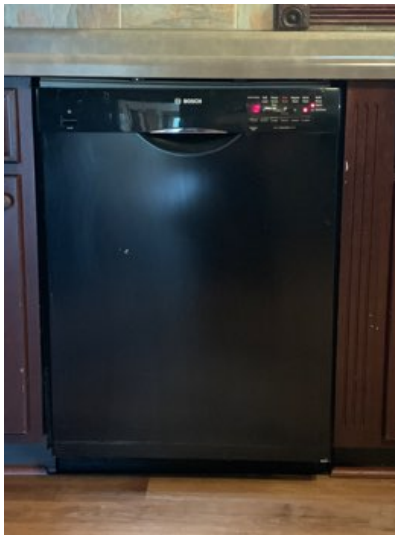
Appeared satisfactory. No significant damage, deterioration or deficiencies observed during the inspection. Operated as designed using normal controls.

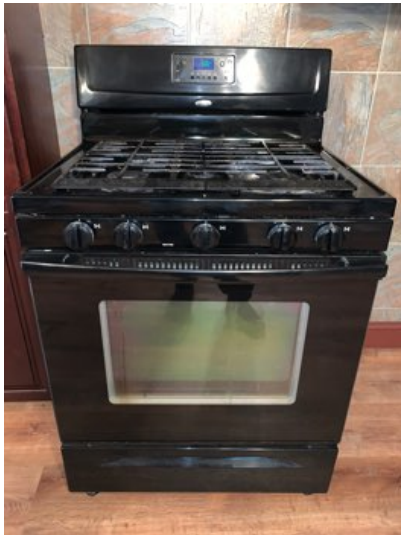
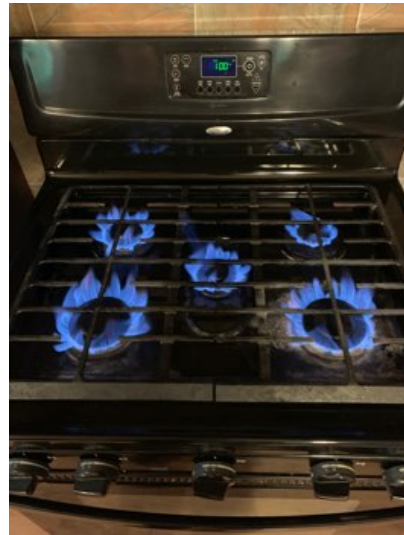
3. Ranges, Ovens, Cooktops

Appeared satisfactory. No significant damage, deterioration or deficiencies observed during the inspection. Operated as designed using normal controls.

All cooktop burners ignite and appear functional.

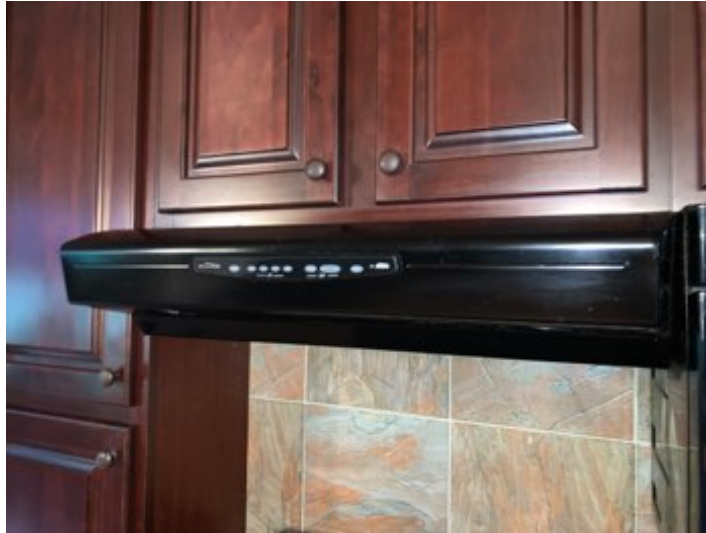
4. Hood/Exhaust Fan

Appeared satisfactory. No significant damage, deterioration or deficiencies observed during the inspection. Operated as designed using normal controls.

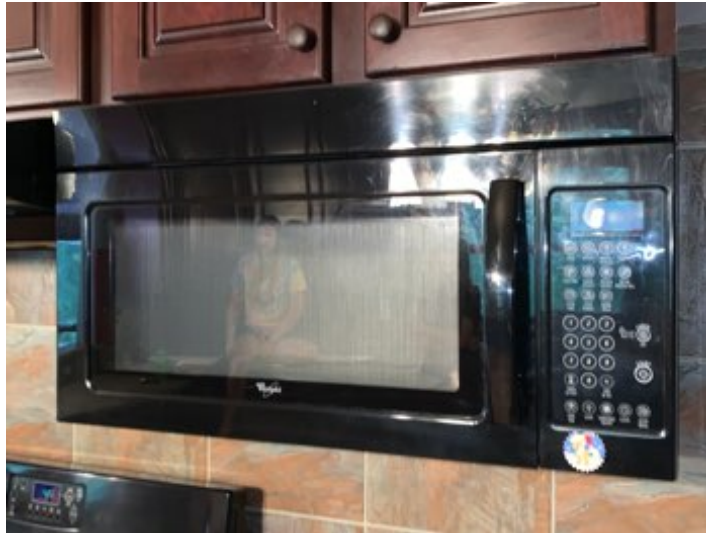
5. Microwave

REPAIR - The light did not work when tested. It is beyond the scope of the inspection to determine the cause. Recommend contacting an appropriate reputable contractor to assess and repair as needed.

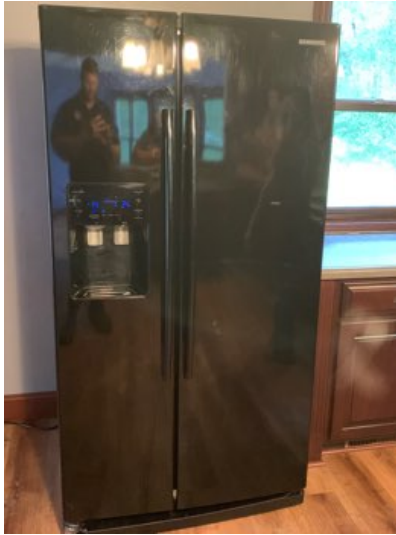
6. Refrigerator

Appeared satisfactory. No significant damage, deterioration or deficiencies observed during the inspection.

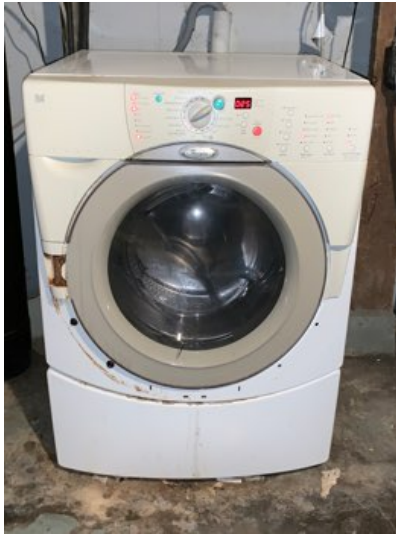
7. Clothes Washer

Appeared satisfactory. No significant damage, deterioration or deficiencies observed during the inspection. Operated as designed using normal controls.

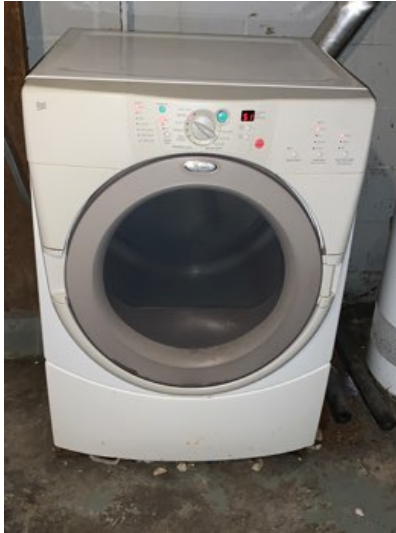
8. Clothes Dryer

Appeared satisfactory. No significant damage, deterioration or deficiencies observed during the inspection. Operated as designed using normal controls.
