Insight Home Inspections

Property Inspection Report

1111 Sample Report Blvd, Davenport, IA 52807
Inspection prepared for: Sample Report
Date of Inspection: 1/1/2019 Time: 8:00am
Age of Home: Built in 2007 Size: 3910 Finished Square Feet

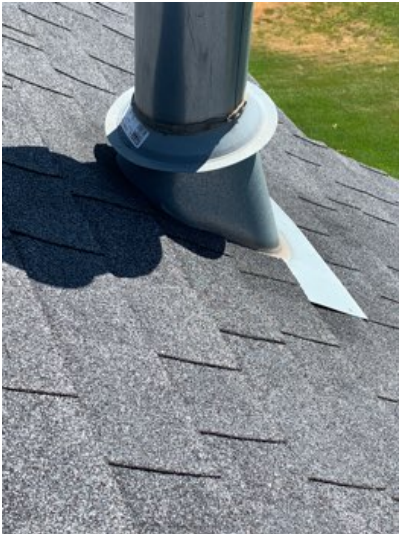
Chimney flashing appears in good condition.

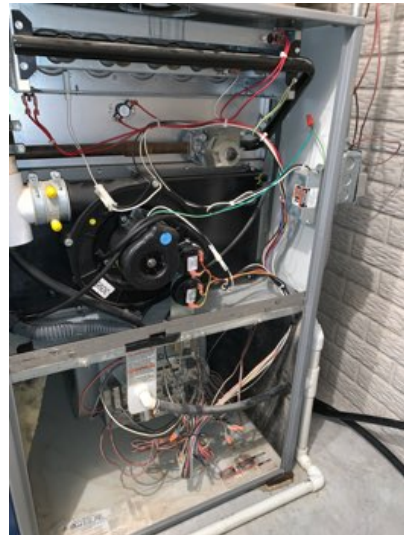
Interior of furnace cabinet: no deficiencies observed.

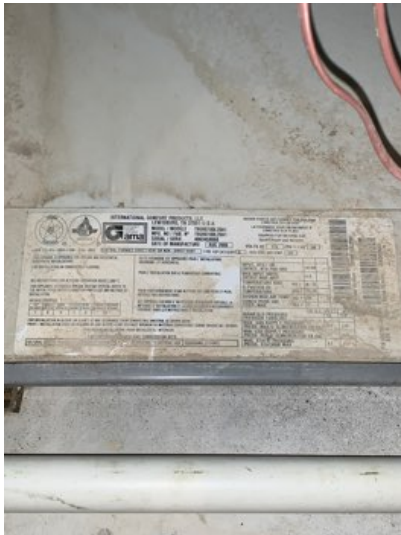
The data plate serial number: A063459068 on the Tempstar brand furnace reads the unit was manufactured in the 34th week, 2006.

Furnace data plate with information and specifications.

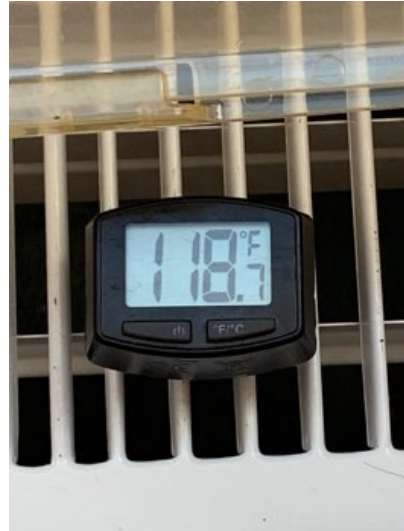
Supply air temperature from furnace.

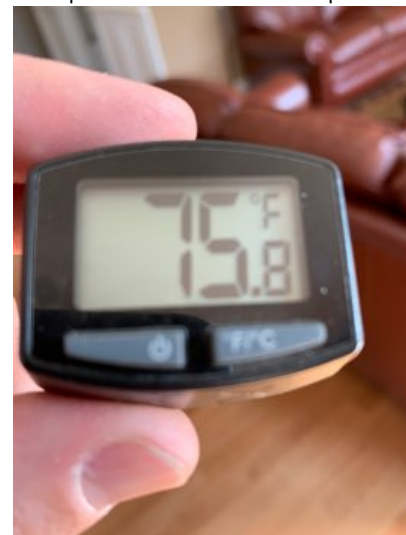
Room temperature at the time of A/C inspection

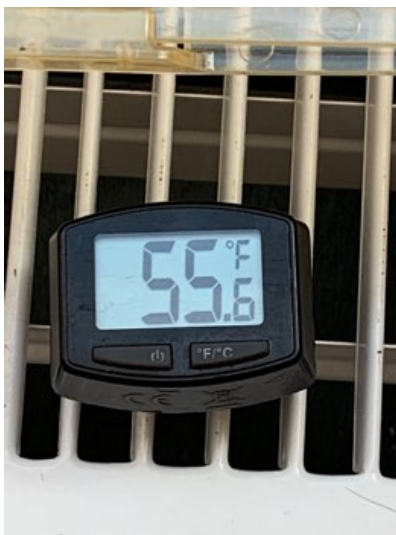
Supply air temperature from A/C unit

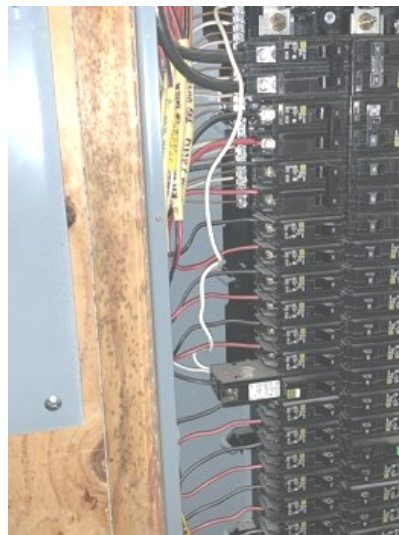
Left side breakers and neutral bus bar: no deficiencies observed.

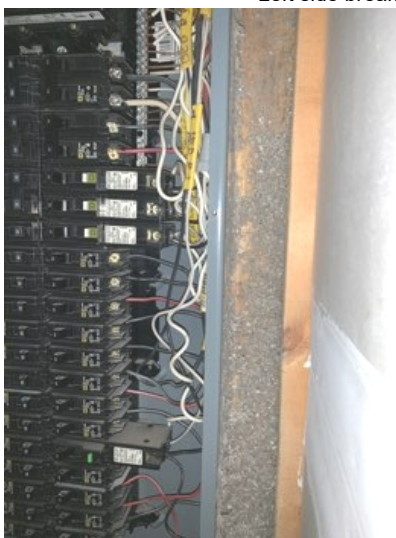
Right side breakers and neutral bus bar: no deficiencies observed.

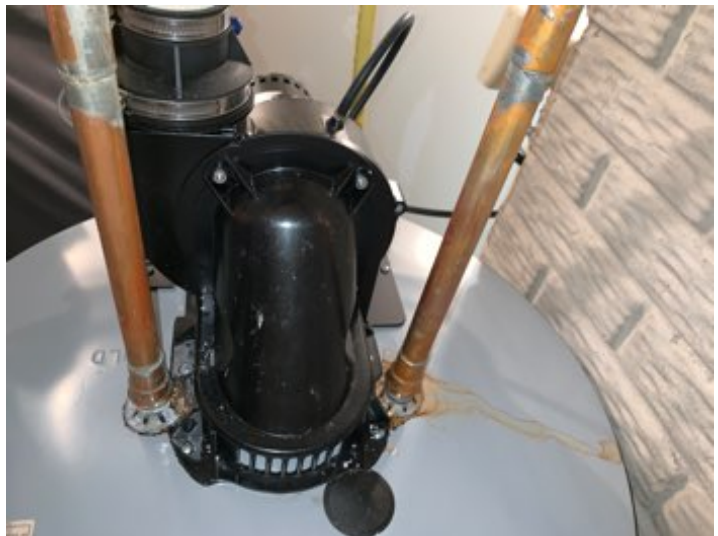
Top of water heater: no leaks, corrosion or damage observed

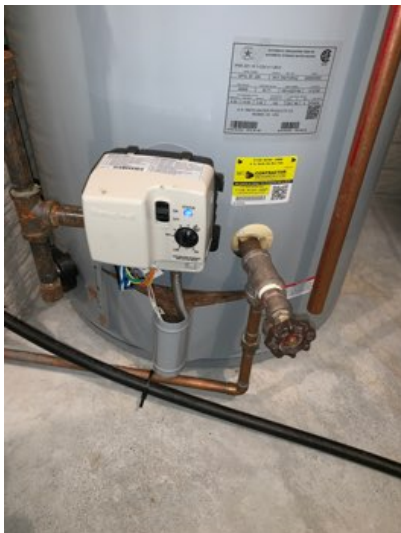
Base of water heater: no leaks, corrosion or damage observed

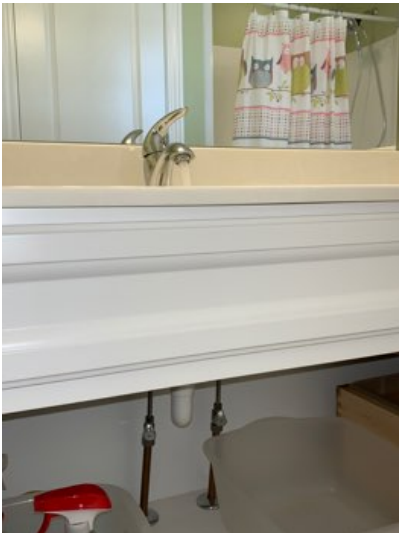
Jack and Jill bathroom sink left: no leaks observed

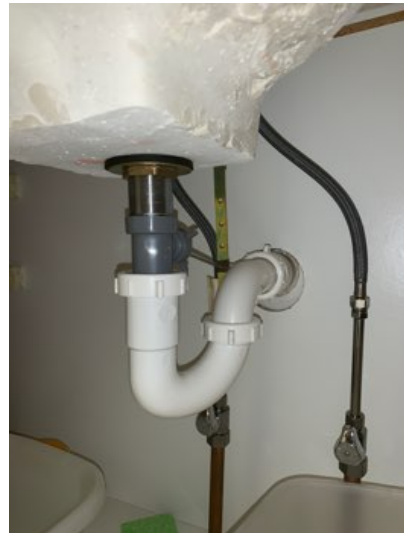
Under Jack and Jill bathroom sink left: no leaks observed

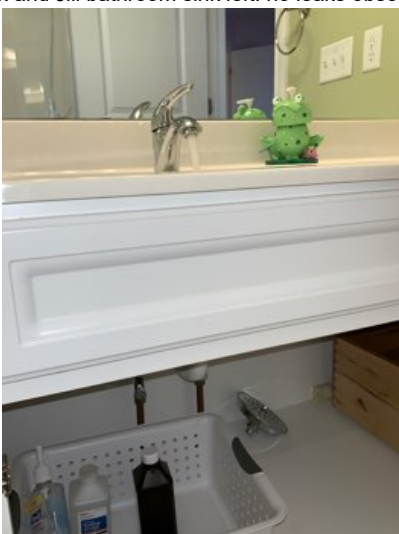
Jack and Jill bathroom sink right: no leaks observed

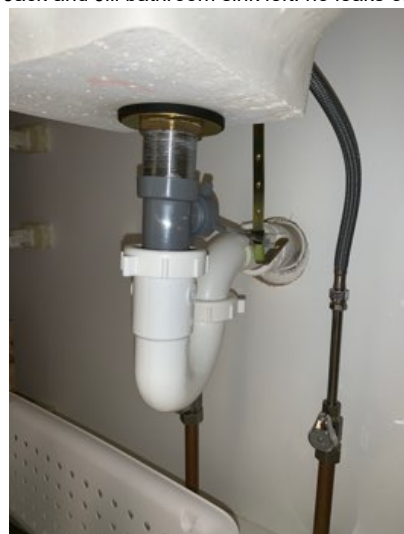
Under Jack and Jill bathroom sink right: no leaks observed

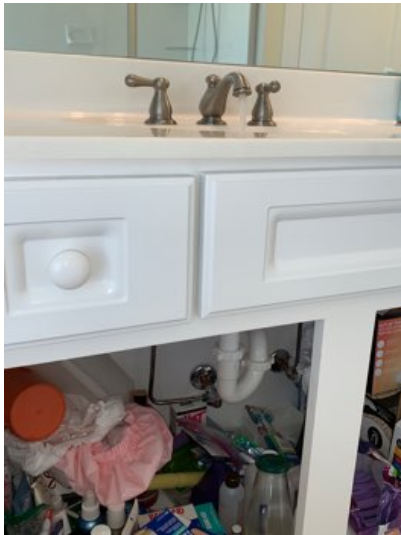
Master bathroom sink left: no leaks observed

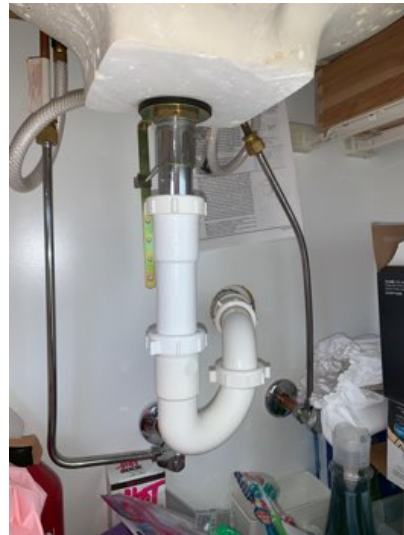
Under master bathroom sink left: no leaks observed

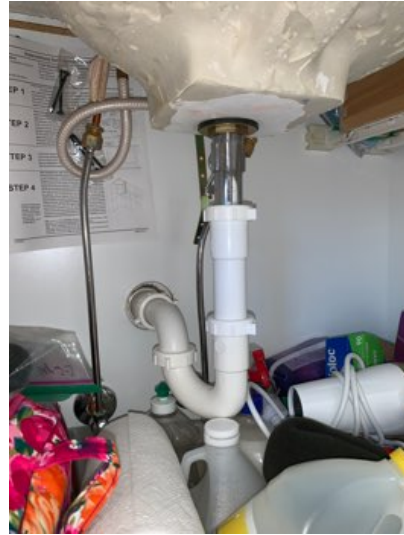
Under master bathroom sink right: no leaks observed

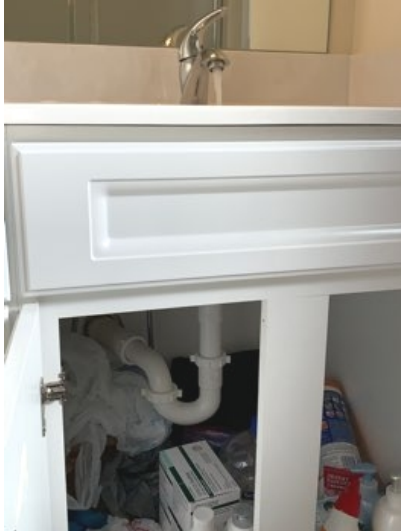
Bedroom bathroom sink: no leaks observed

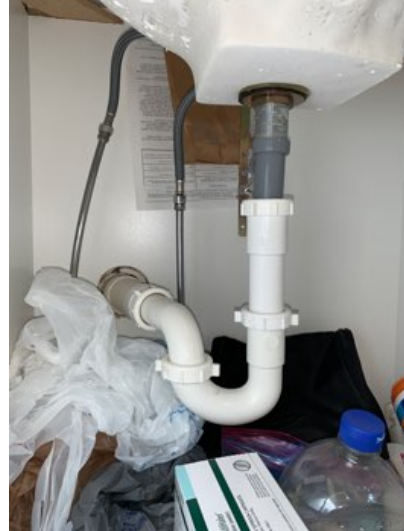
Under bedroom bathroom sink: no leaks observed

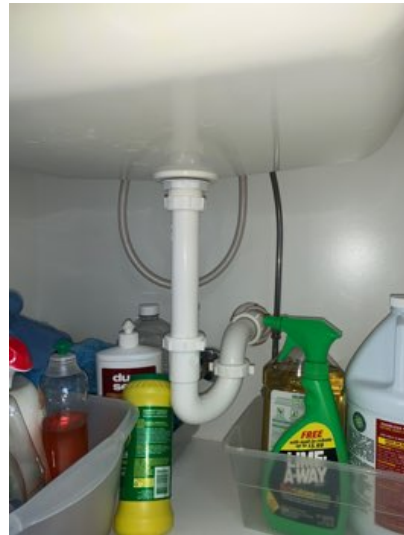
Under laundry sink: no leaks observed

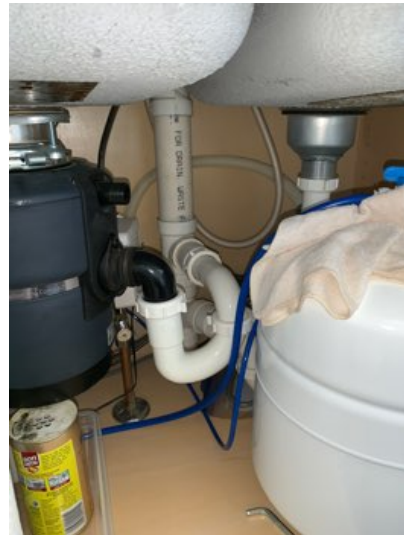
Under kitchen sink: no leaks observed

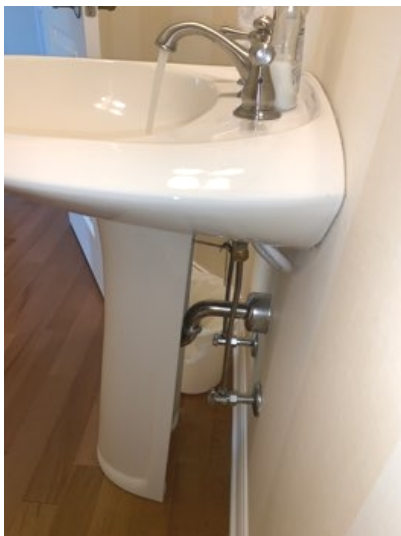
Half bathroom sink: no leaks observed.

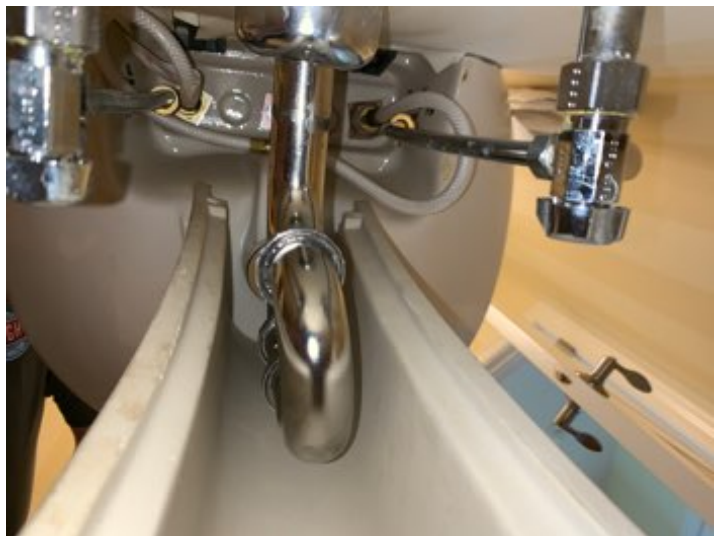
Under half bathroom sink: no leaks observed

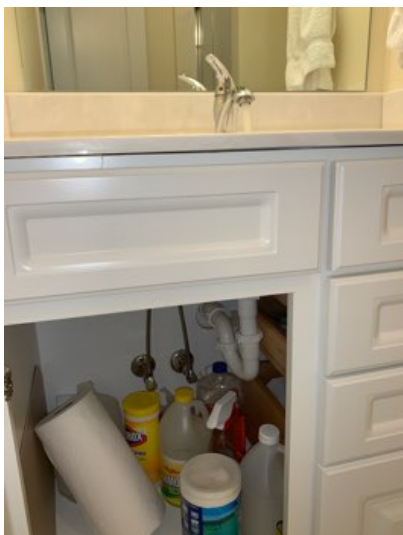
Basement bathroom sink: no leaks observed

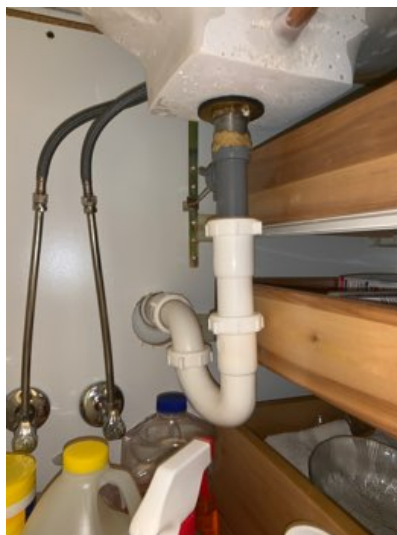
Under basement bathroom sink: no leaks observed

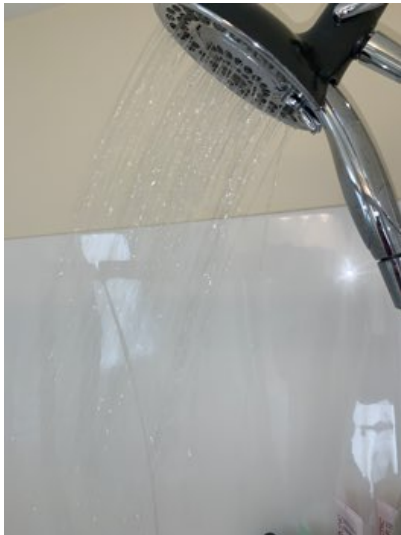
Bedroom bathroom shower
