Property Location: 203 West Main Street, Morrison, IL 61270

INSPECTION REPORT

Prepared For: Gold Standard Ventures

Date of Inspection: 6/2/2025

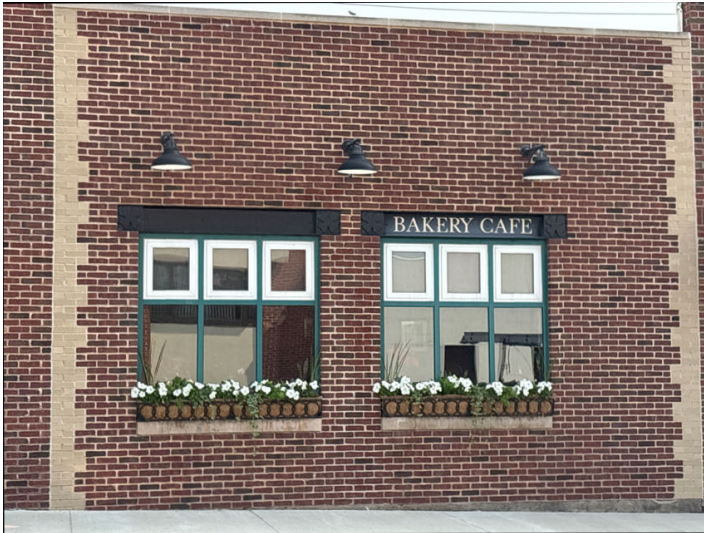
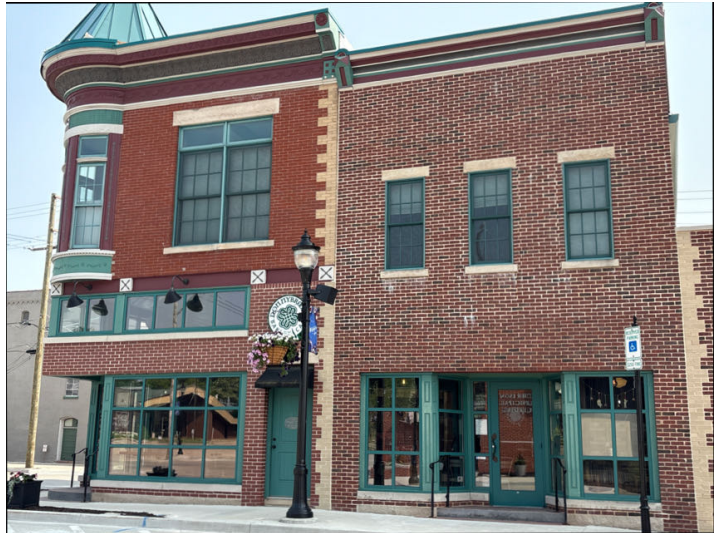
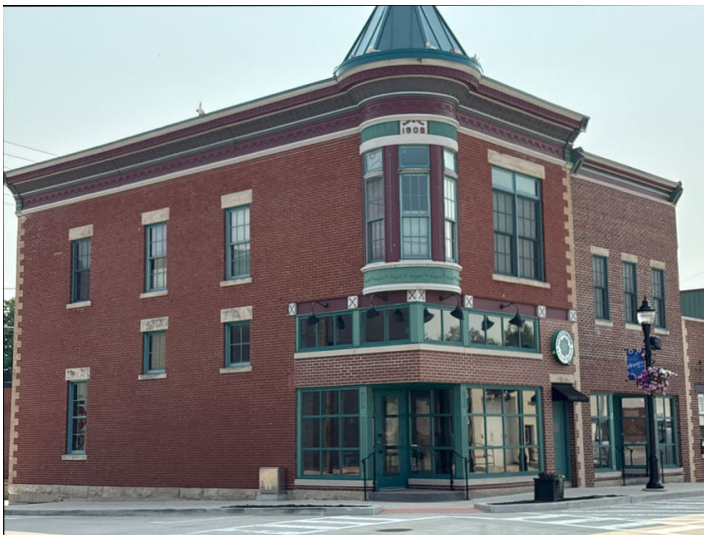
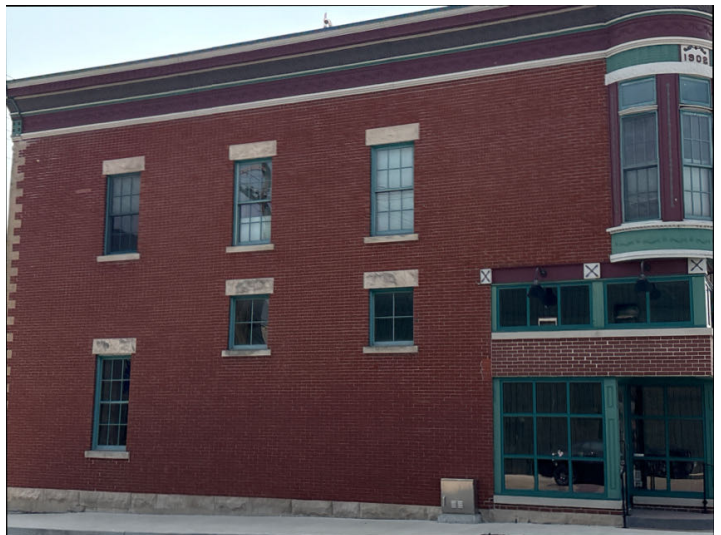
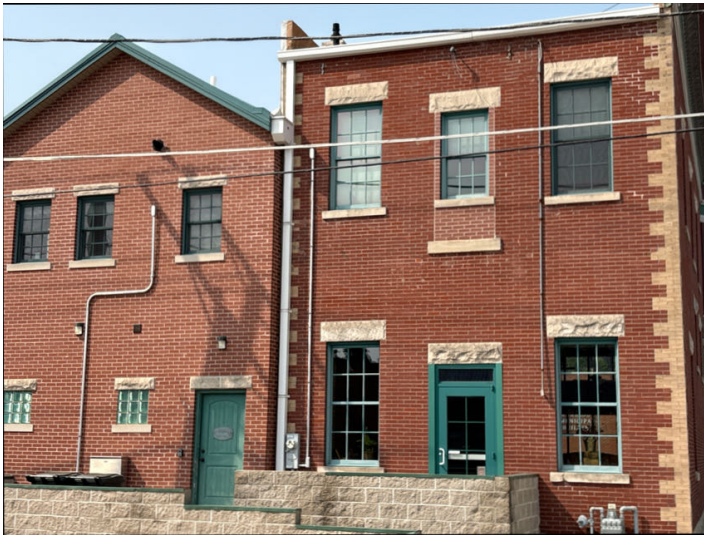
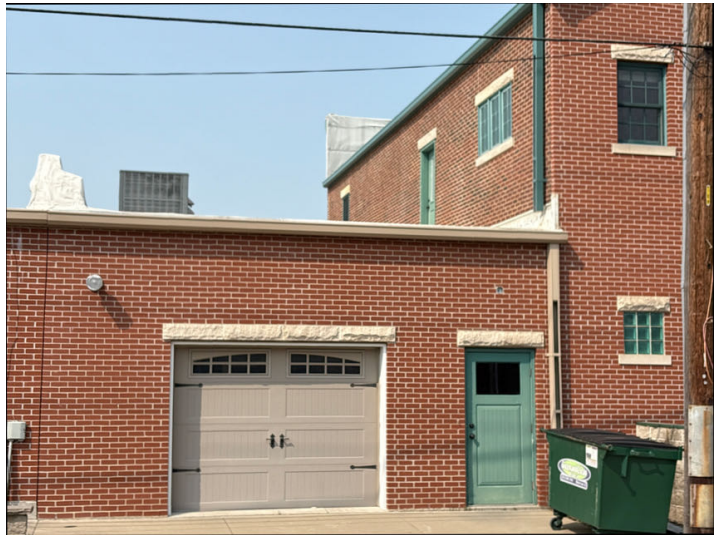
Damage to one stone window ledge was observed. This may allow water to penetrate behind the brick as well as water to enter the building. Water may cause damage to structural components, interior finishes, and may encourage mold growth. All damage should be repaired before additional damage occurs. Recommend contacting an appropriate reputable contractor to assess and repair as needed.

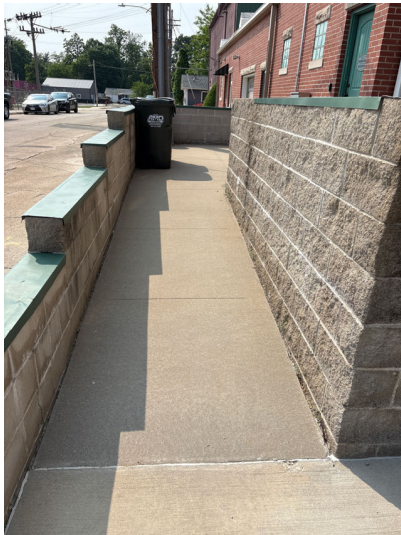
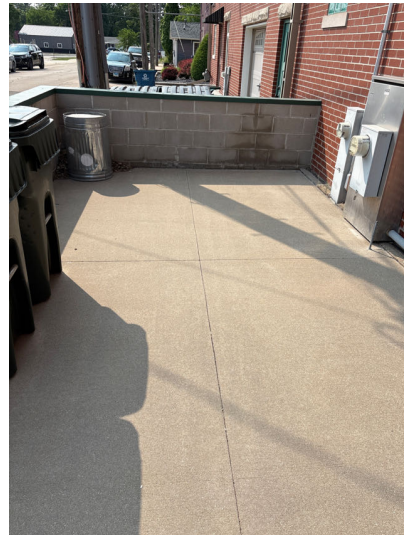
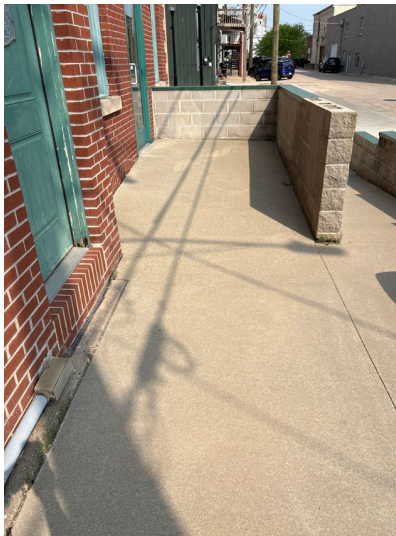
2. Walkways

Appeared satisfactory. No significant damage, deterioration or deficiencies observed during the inspection.

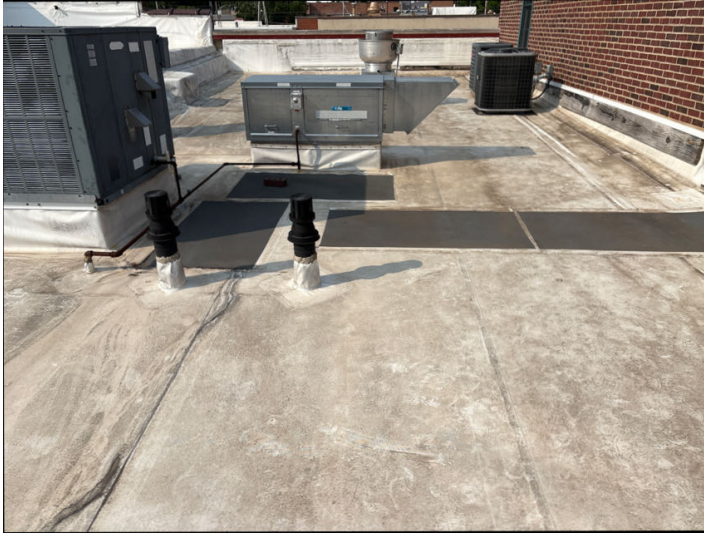
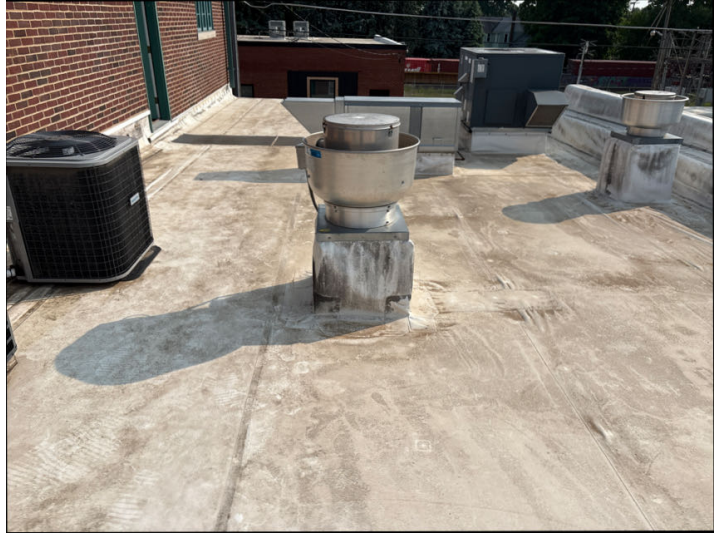
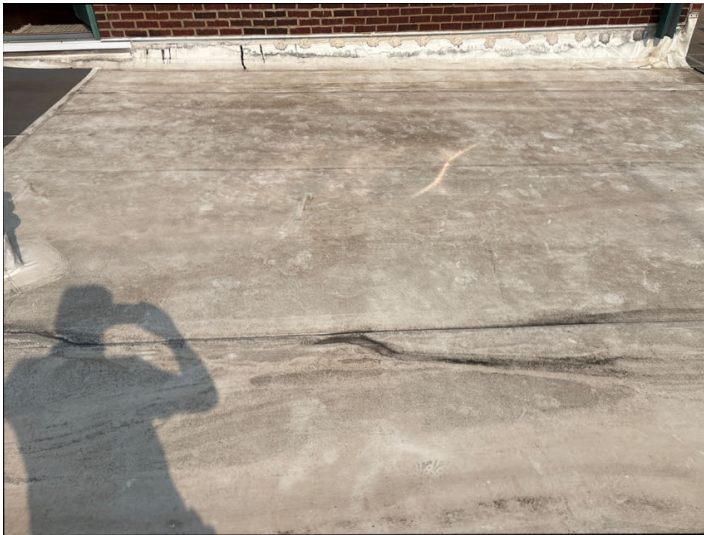
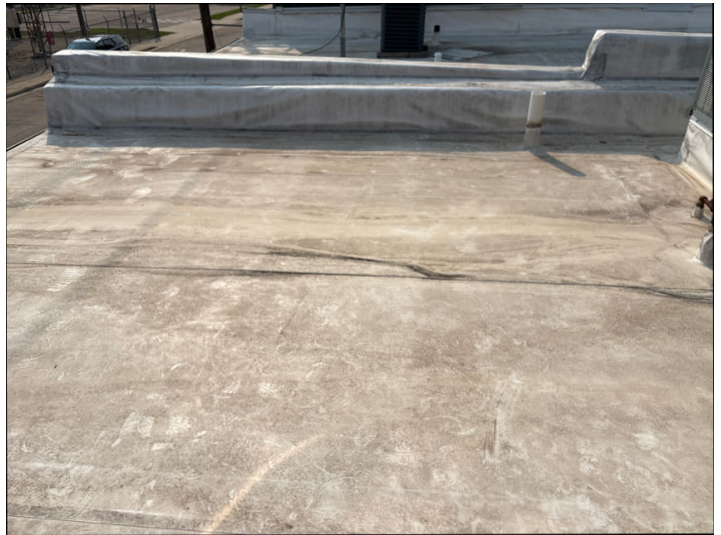
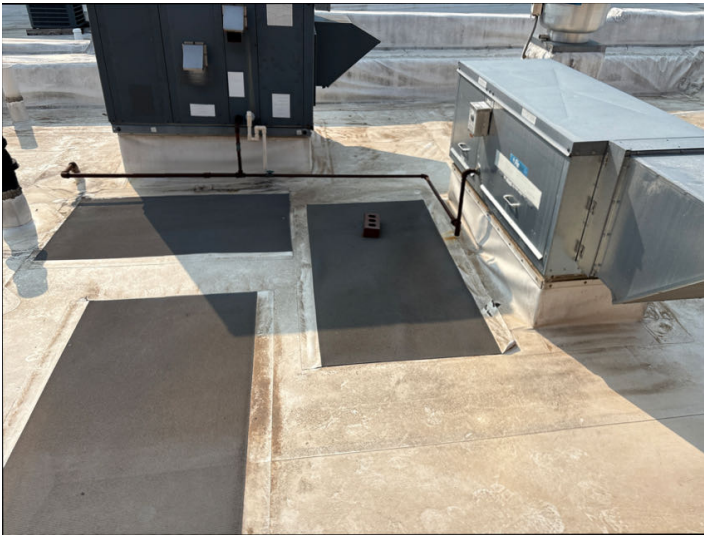
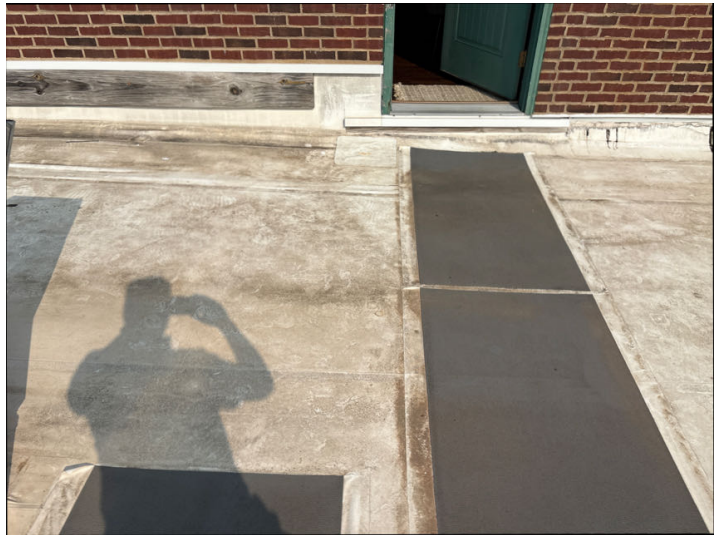
Appeared satisfactory. No significant damage, deterioration or deficiencies observed during the inspection.

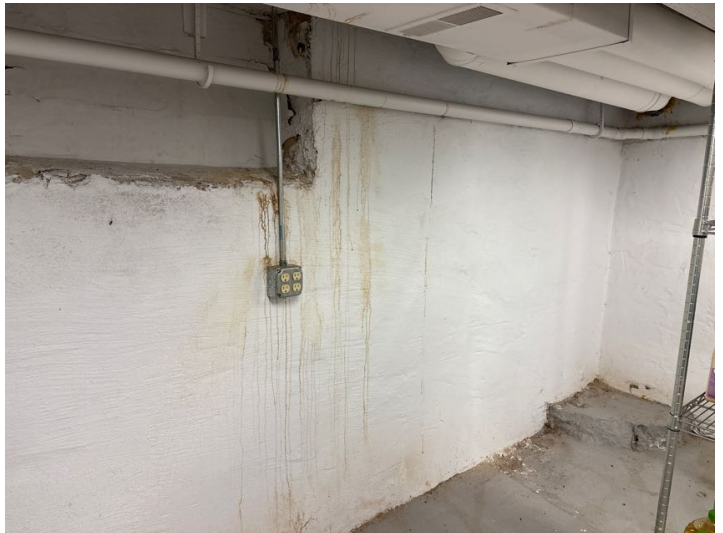
Evidence of moisture intrusion observed. Moisture can damage building finishes and structural components as well as contribute to the development of mold. Recommend contacting an appropriate reputable contractor to assess and repair as needed.

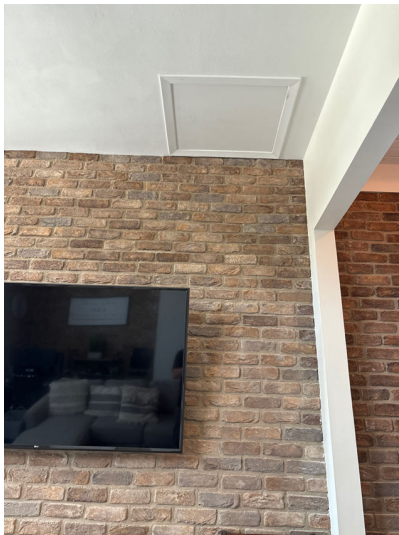
The corporate rental unit attic space/roof structure scuttle access was obstructed by the television and not accessible. Attic space, roof structure, and components were not inspected. Condition is unknown.

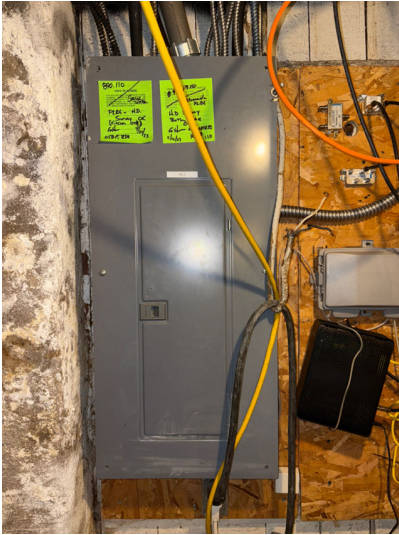
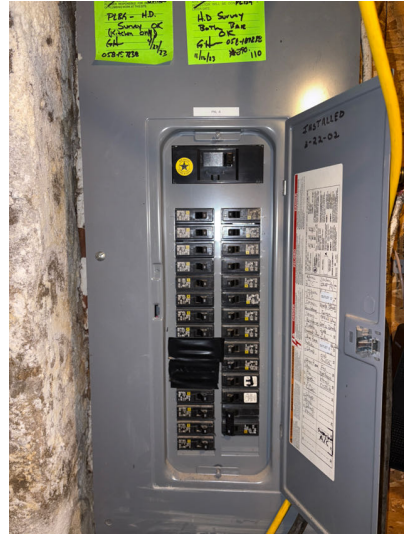
Panel A

The bakery Café electrical panels were serviced with three phase electrical from the utility company. Three phase electrical panels are not opened to inspect the interior for safety reasons.

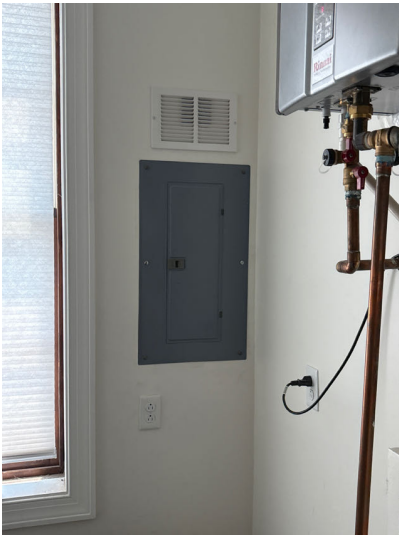
Corporate rental unit panel

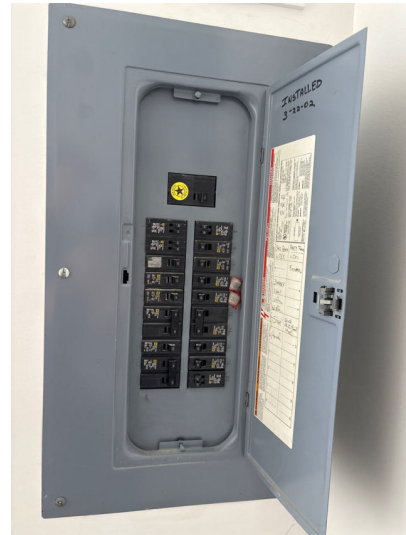
Corporate rental unit panel

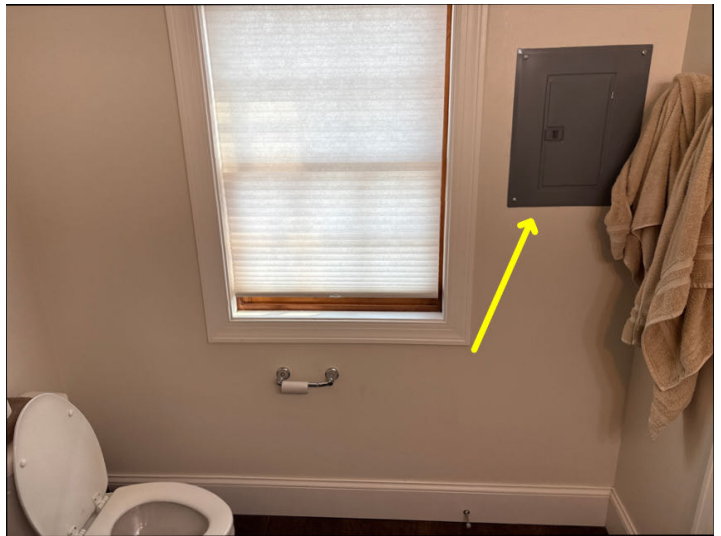
The Airbnb electrical panel was located in the bathroom. This creates a potential hazard and is considered less safe. Recommend contacting a certified electrical contractor to properly relocate the panel.

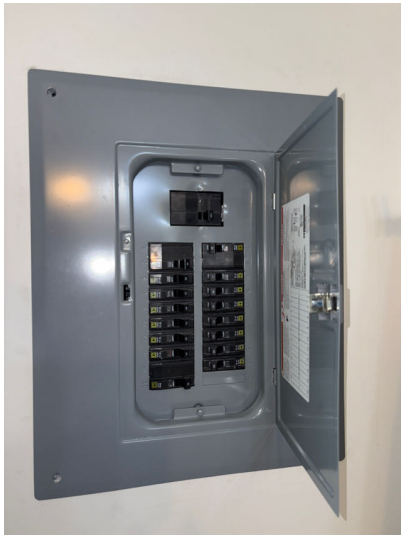
Airbnb panel - Multiple tapping observed at number one (double pole) circuit breaker. This is considered improper and less safe. Recommend contacting a certified electrical contractor to assess and repair as needed.

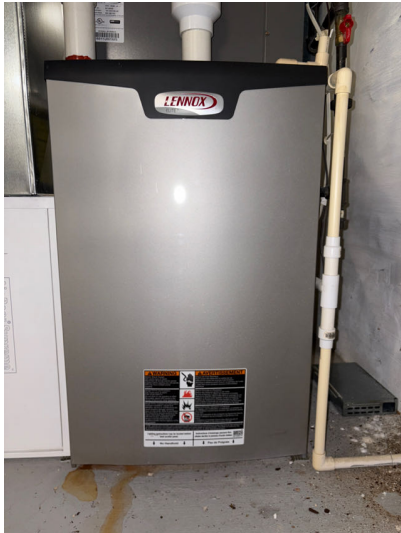
Bakery Café Lennox brand furnace.

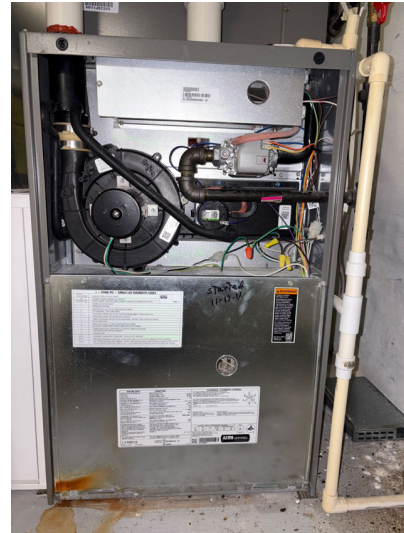
Interior of furnace cabinet: no deficiencies observed.

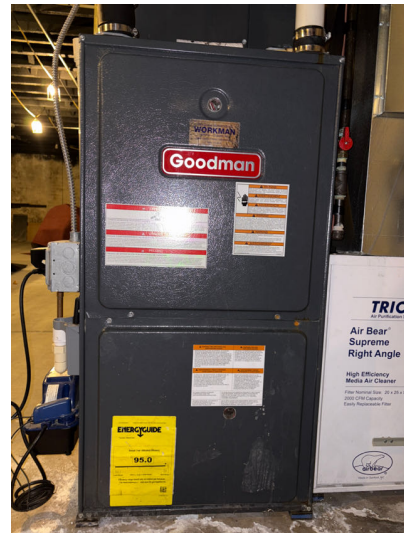
Bakery Café Goodman brand furnace.

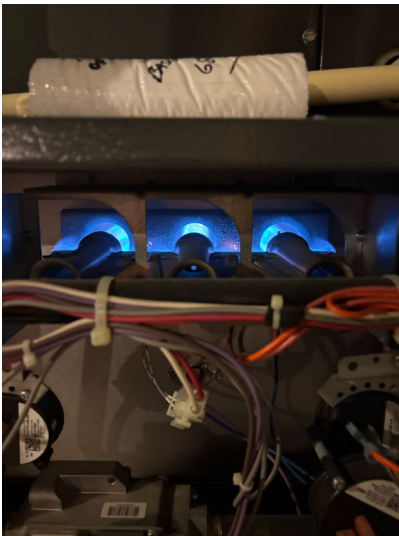
Flames burn bright blue indicating proper fuel combustion.

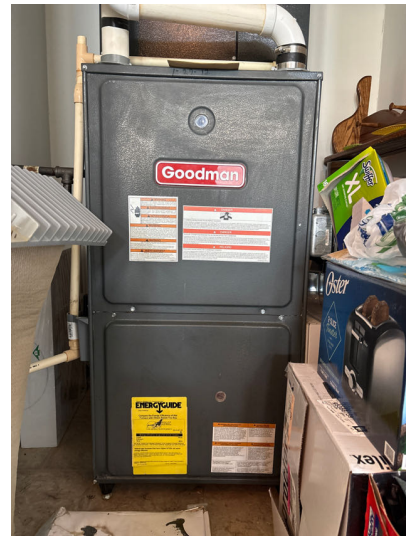
Corporate rental unit Goodman brand furnace

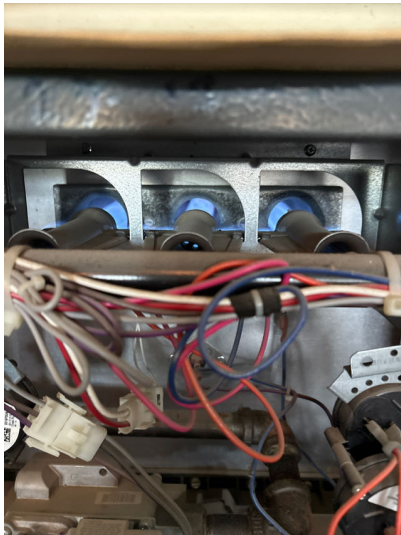
Flames burn bright blue indicating proper fuel combustion.

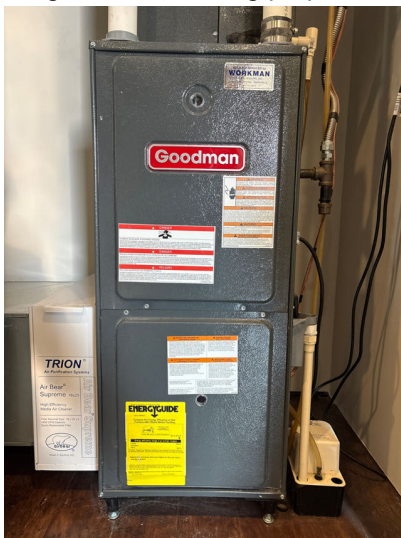
Airbnb Goodman brand furnace

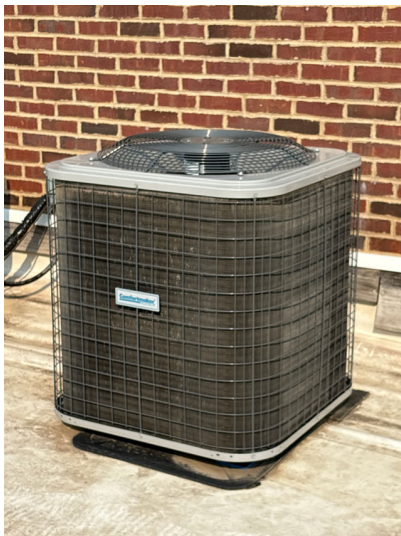
ComfortMaker brand central A/C unit.

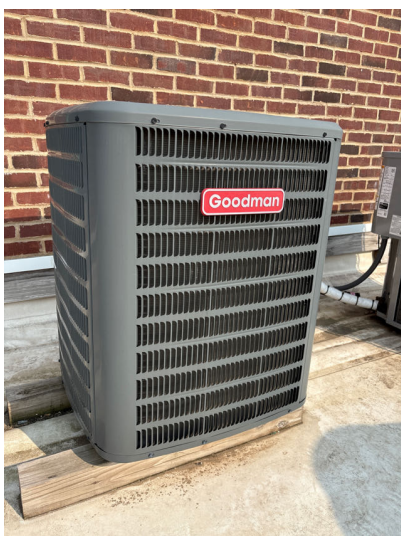
Goodman brand central A/C unit.

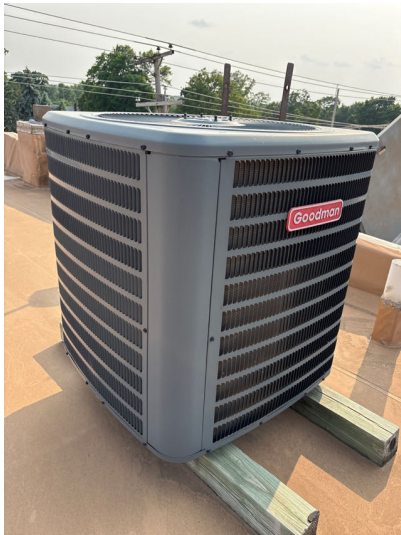
Corporate rental unit Goodman brand central A/C unit.

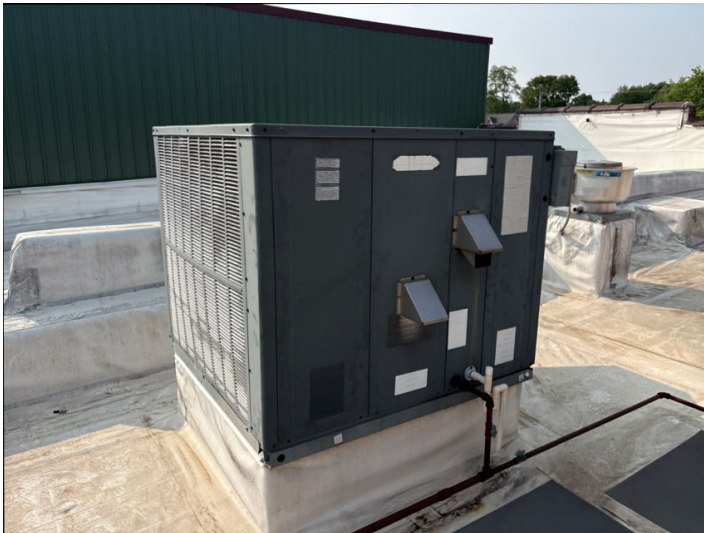
Unable to determine brand age and size.

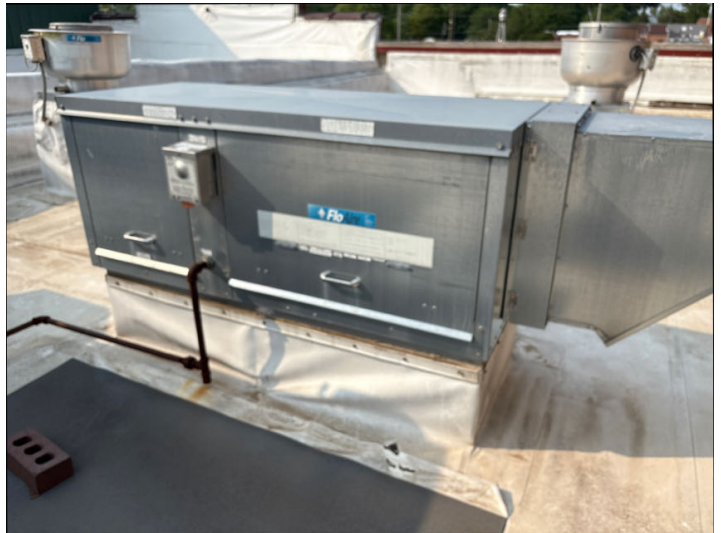
Unable to determine brand, age and size.

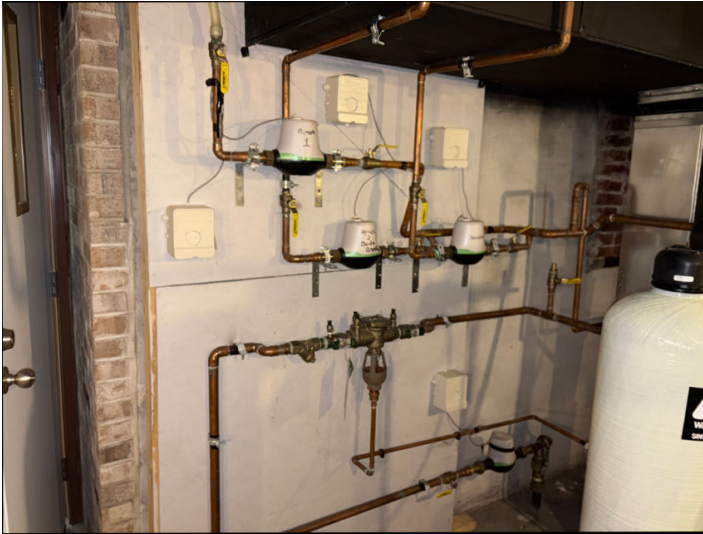
Water meters and shut off valves.

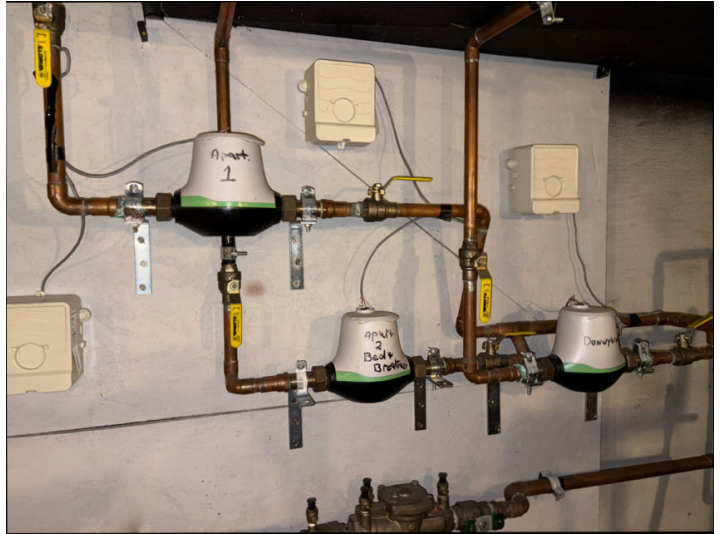
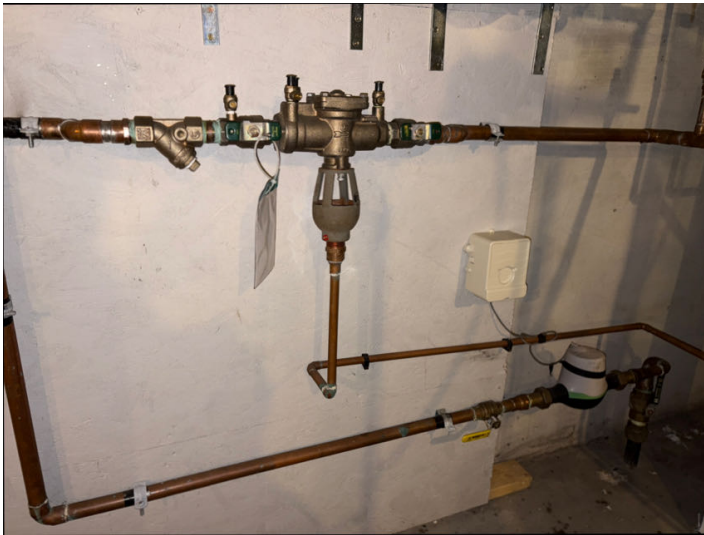
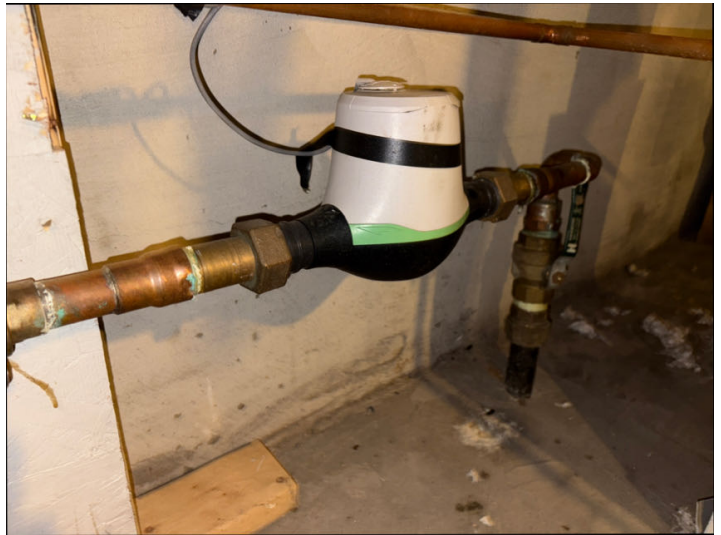
Water supply, meter shut off valve.

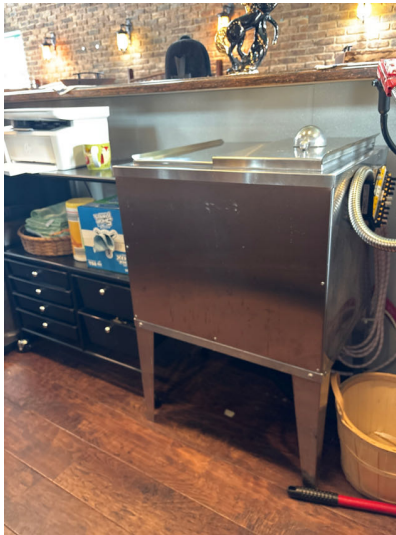
The barista ice bin did not have a drain installed. Recommend a permanent drain be installed.

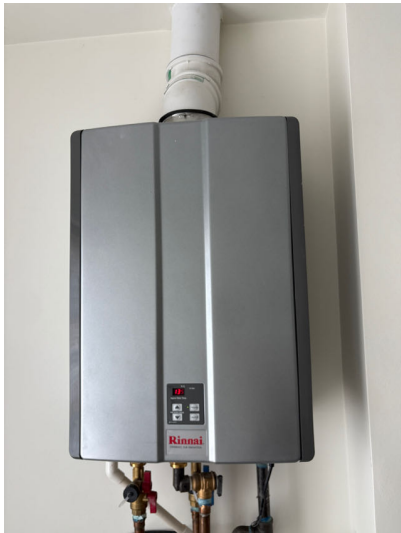
Corporate rental unit Rinnai brand water heater

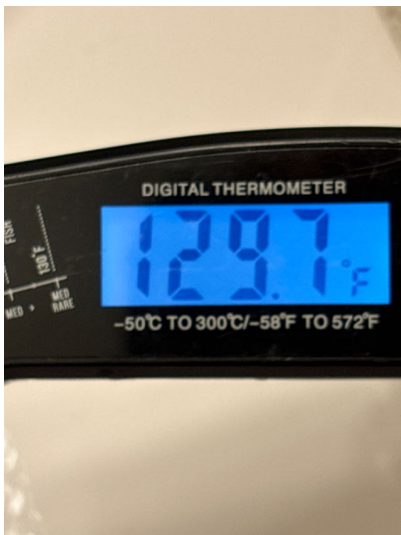
Hot water temperature taken at the corporate rental bathroom sink

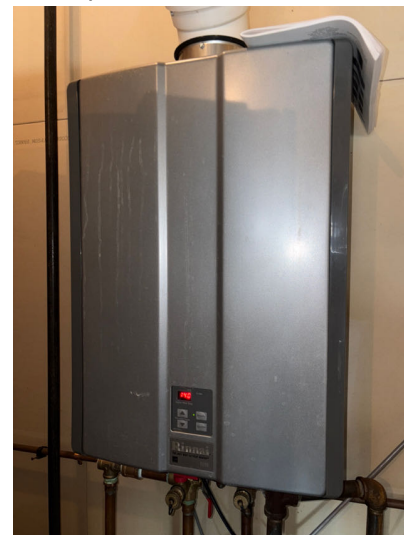
Bakery Café Rinnai brand water heater

REPAIR - Water leak from the bakery cafe left unit observed. The bakery cafe owner stated the unit also shuts down and displays an error code on a regular basis. Recommend contacting a reputable licensed plumbing contractor to assess and repair as needed.

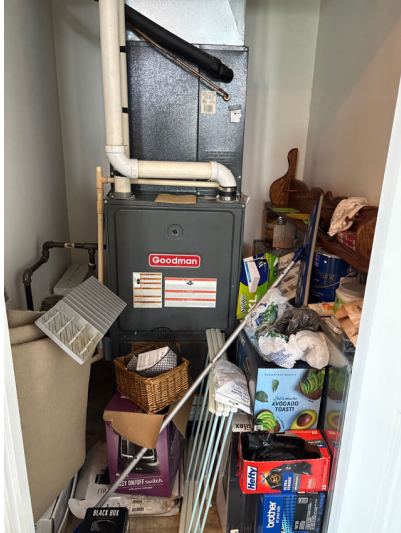
Storage, paints and wood stain were stored in the corporate rental unit furnace room. Recommend flammable items be removed.

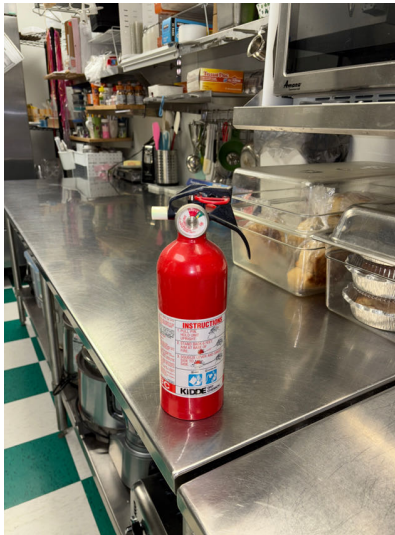
No portable fire extinguishers were observed in the bakery Café dining areas. One portable fire extinguisher was observed in the kitchen. That fire extinguisher appeared to be off the shelf store-bought with no inspection tag present. Recommend portable fire extinguishers be placed appropriately by a certified fire control systems company.

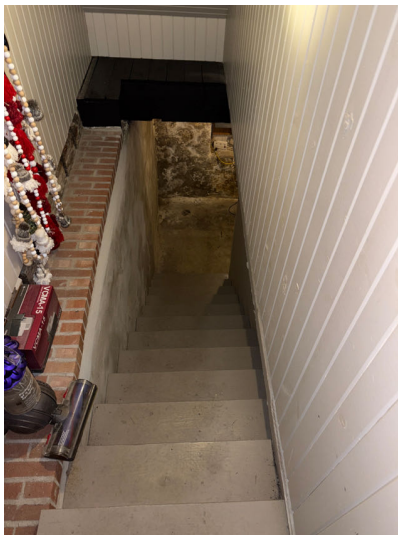
The basement steps were not equipped with a handrail. This is less safe. Recommend a handrail will be installed for safety.

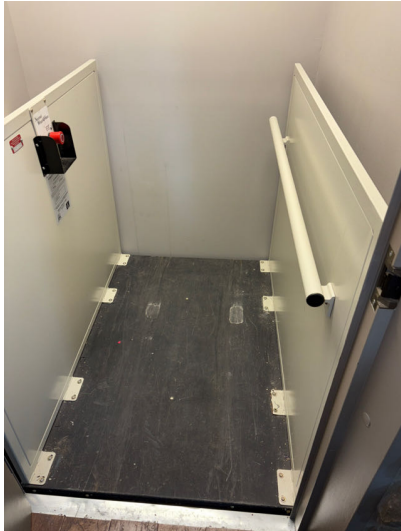
The certificate of operation expired September 26, 2014.
