Insight Home Inspections

Property Inspection Report

1111 Sample Report Blvd, Davenport, IA 52807
Inspection prepared for: Sample Report
Date of Inspection: 1/1/2019 Time: 8:00am
Age of Home: Built in 2007 Size: 3910 Finished Square Feet

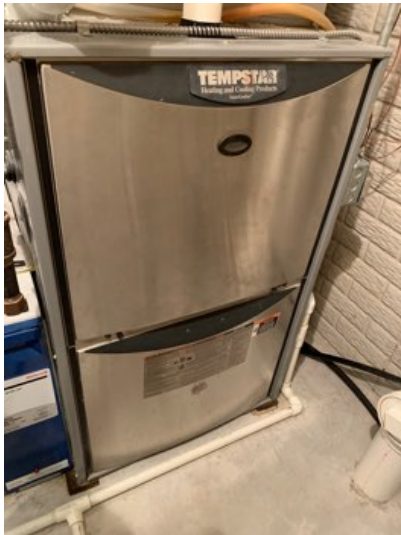
Tempstar brand high efficient furnace.

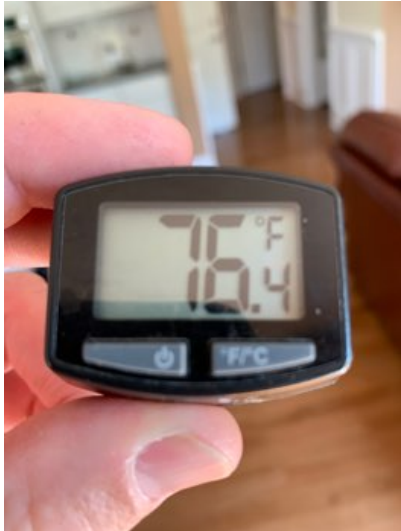
Room temperature at the time of inspection.

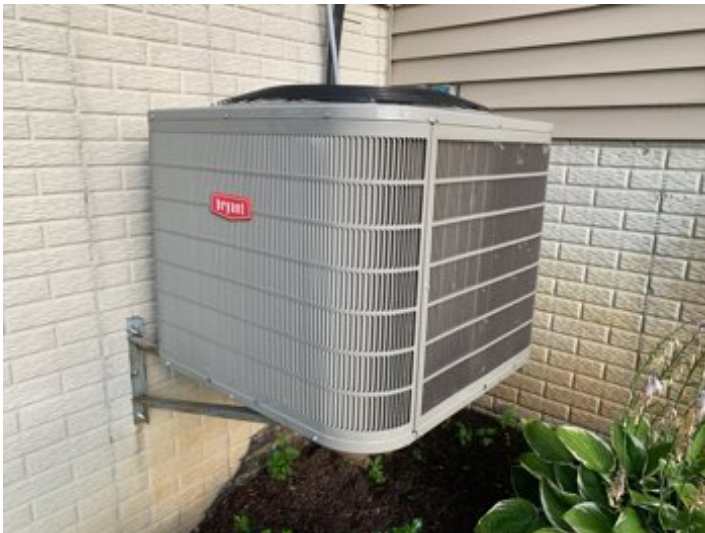
Bryant brand central A/C unit.

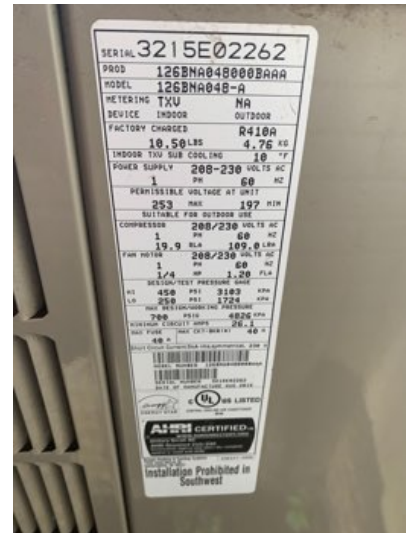
The data plate serial number: 3215E02262 on the Bryant brand central A/C reads the unit was manufactured in the 32nd week, 2015.

The data plate model number: 126BNA048-A on the Bryant brand central A/C reads the unit's cooling capacity is 4 tons.

A/C data plate with information and specifications

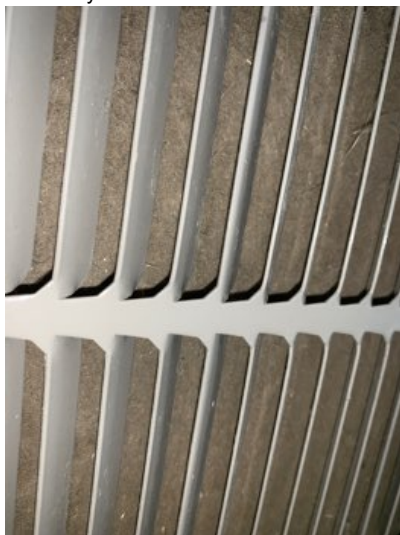
MAINTENANCE - The exterior coil was dirty and needs cleaned. Keeping the coil clean will help with efficiency and help prevent premature failure. Recommend cleaning the coil upon possession of the home and annually thereafter.

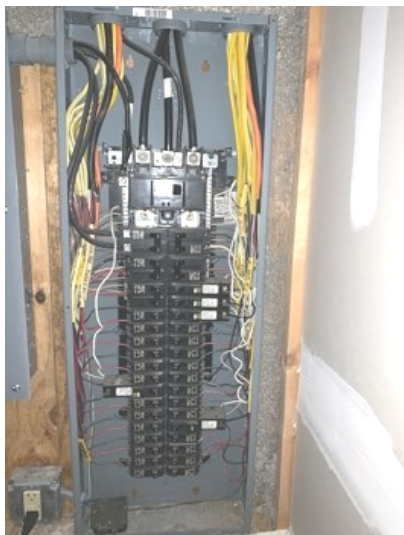
Left side breakers and neutral bus bar: no deficiencies observed.

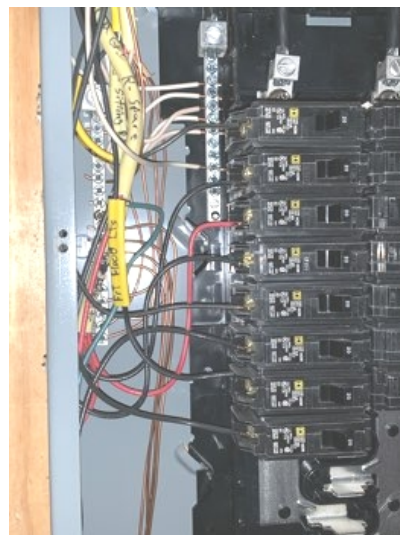
Left side breakers and neutral bus bar: no deficiencies observed.

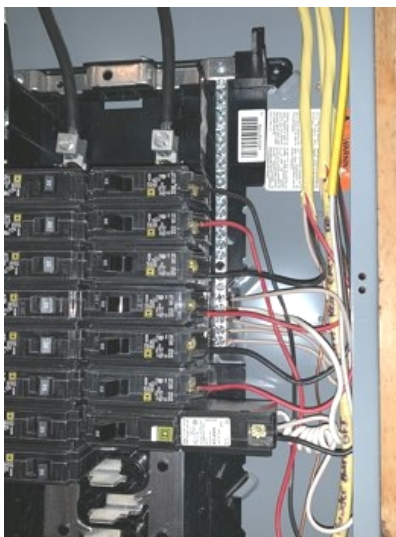
Right side breakers and neutral bus bar: no deficiencies observed.

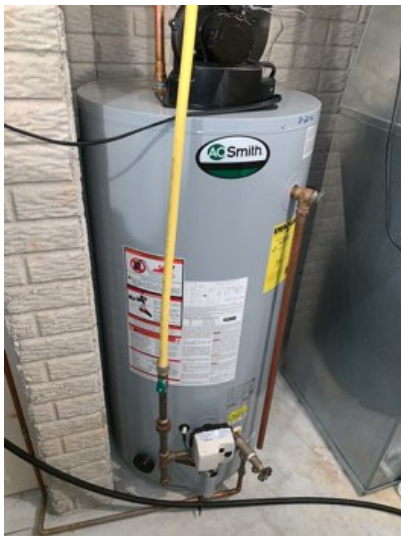
AO Smith brand water heater

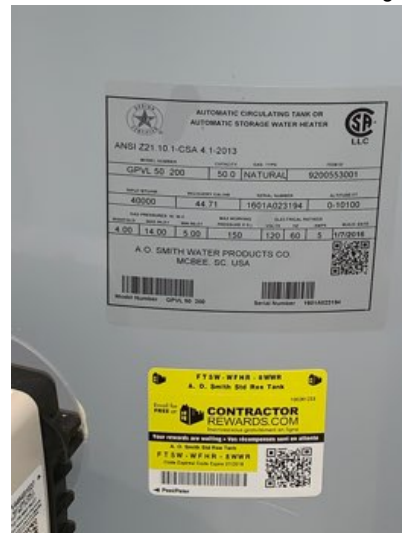
The data plate serial number: 1601A023194 on the AO Smith water heater reads the unit was manufactured in January, 2016.

Water heater data plate with information and specifications

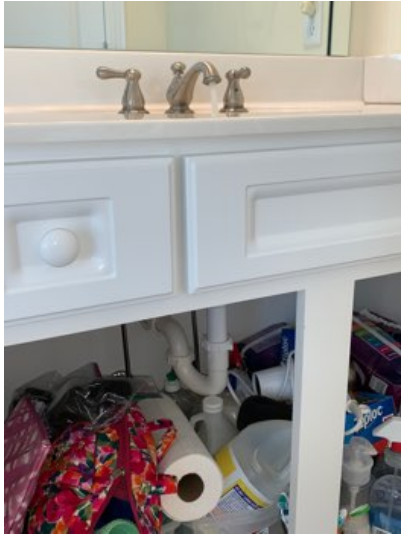
Master bathroom sink right: no leaks observed

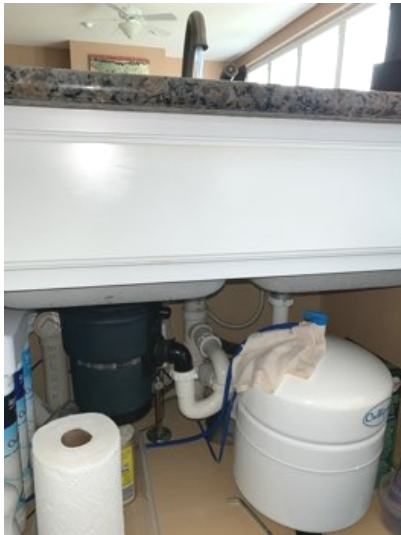
Kitchen sink: no leaks observed

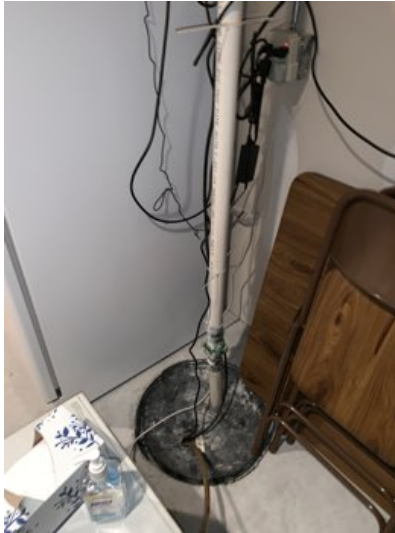
RECOMMENDATION - The sump pump was not equipped with a battery back up system. A battery back up system supplies the pump with electricity when the power company's electricity is interrupted keeping the pump on when needed. Recommend purchasing a battery back up upon possession of the home.

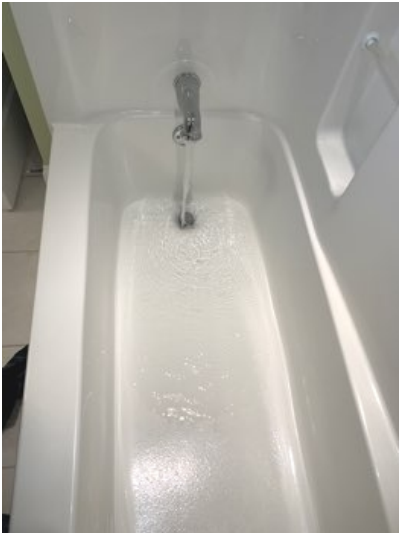
Jack and Jill bathroom tub

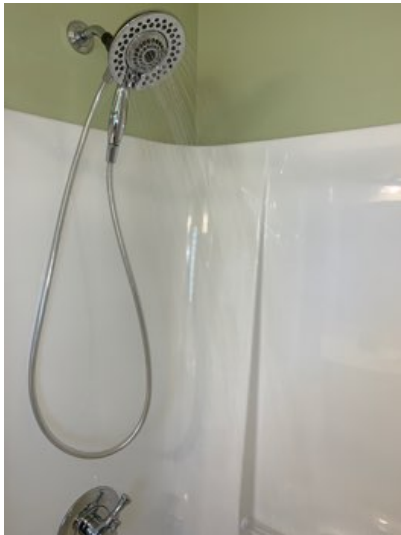
Jack and Jill bathroom shower

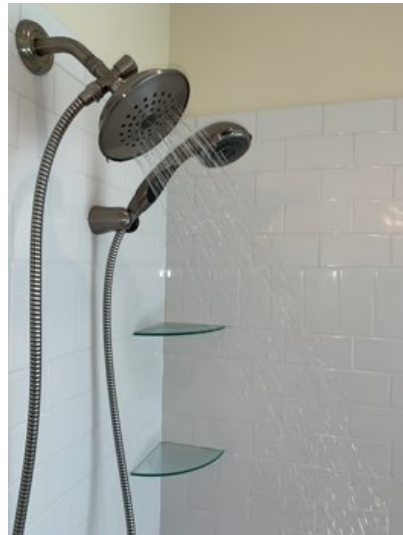
Master bathroom shower

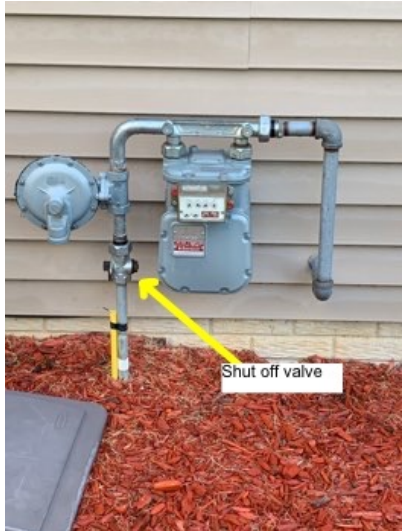
Gas supply, meter, and whole house shut off valve.

REPAIR - Corrugated Stainless Steel Tubing (**CSST**) was present with no proper bonding to the grounding electrode, electrical service equipment enclosure, or the grounded conductor at the electrical service. This may lead to damage and fire from a lightning strike near or to the home. Recommend contacting a reputable electrical contractor to properly bond the CSST.

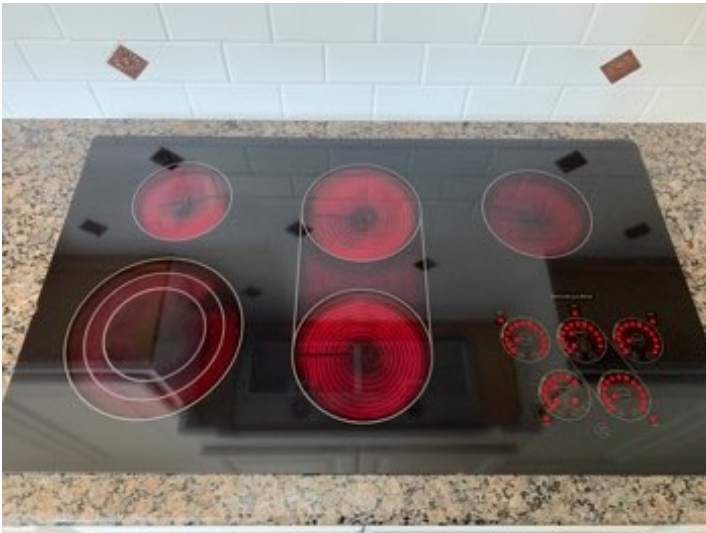
All cooktop elements heat and appear functional.
